## Black Point Beach Association Report Pier/Groin Structures October 2020

The Black Point Beach Association (BPtBA) maintains four erosion/beach control structures at their beach areas fronting the west side of Niantic Bay on Long Island Sound along with a drainage pipe outlet.

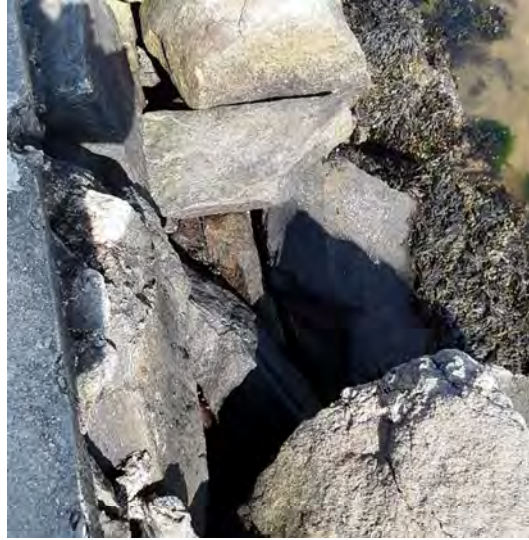
For Piers A,C and D there are areas where the armor stone has gaps which need to be filled to provide an effective profile. This should be done with appropriate size stone and we recommend pieces weighing at least 2400 lbs. minimum with angular proportions. Stone should be placed to provide interlock with adjacent stones and placed to provide an approximate 2 to 1 horizontal to vertical slope. Approximate areas of this work are shown on the attached plan layouts of the piers. Stone replacement and void infills should be accomplished with new stone, not reclaimed stones from the front of the revetment as this could destabilize the structure and this work should be undertaken in a timely fashion such as in the next 5 years.

Gap in Armor Stone Revetment Requiring New Stone Infill

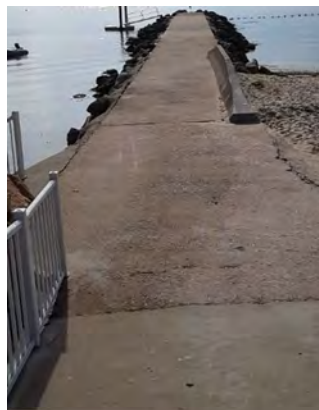
North Groin Paving

The concrete paving appears to be of different ages and is worn but serviceable. Maintenance should be considered in areas where joints are opening and or where vegetation is growing. This will slow down further deterioration and avoid tripping hazards on the deck.

Repair for these deteriorated conditions would include removal of any loose cracked/crumbling concrete with new patching placed with depth and bonding to adhere to the substrate concrete. We would also recommend removal of any vegetation growing within joints in the paving as this will speed up deterioration at these joints. This type of work should be considered yearly maintenance provided on an as needed basis.

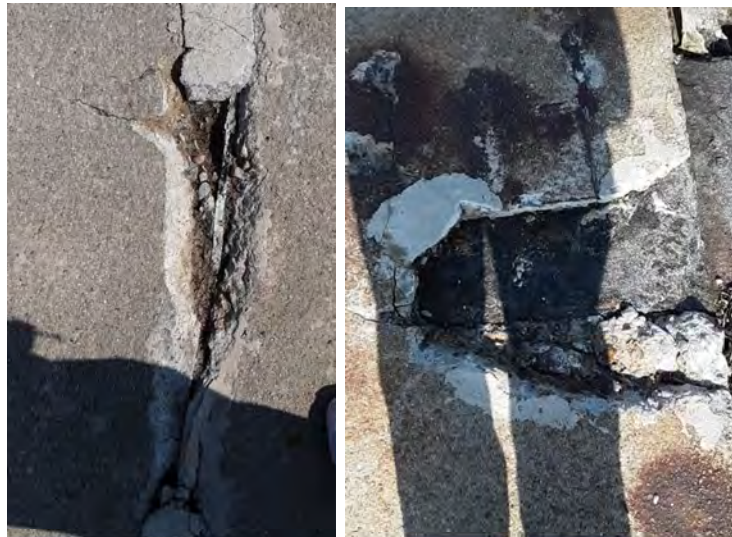
Paving Deterioration

Paving Pothole

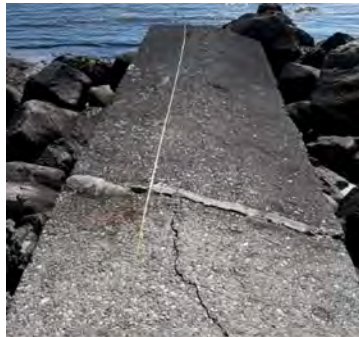
The concrete cap structure is intended to provide protection of an approximate 30 inch diameter precast concrete pipe that drains street runoff into the bay. It has a cast-in-place concrete covering over the top and sides from some distance landward out to the discharge end which is partially surrounded by stone to prevent clogging from sand and small stones. The last 21 feet of the enclosure and pipe have broken and settled away from the landside section with a break and separation at the last section. This has allowed the discharge end to shift (rotate counterclockwise 20 degrees or so) and thus compromised the pipe and its hydraulic cross-section limiting its function. Further deterioration will eventually cause the drainage to become clogged.

Drainage Pipe Concrete Encasement

Broken Last Section of Pipe

We would recommend that the end section of this pipe be replaced with new concrete encasement established back to the break (approximately 21 feet) as soon as possible.

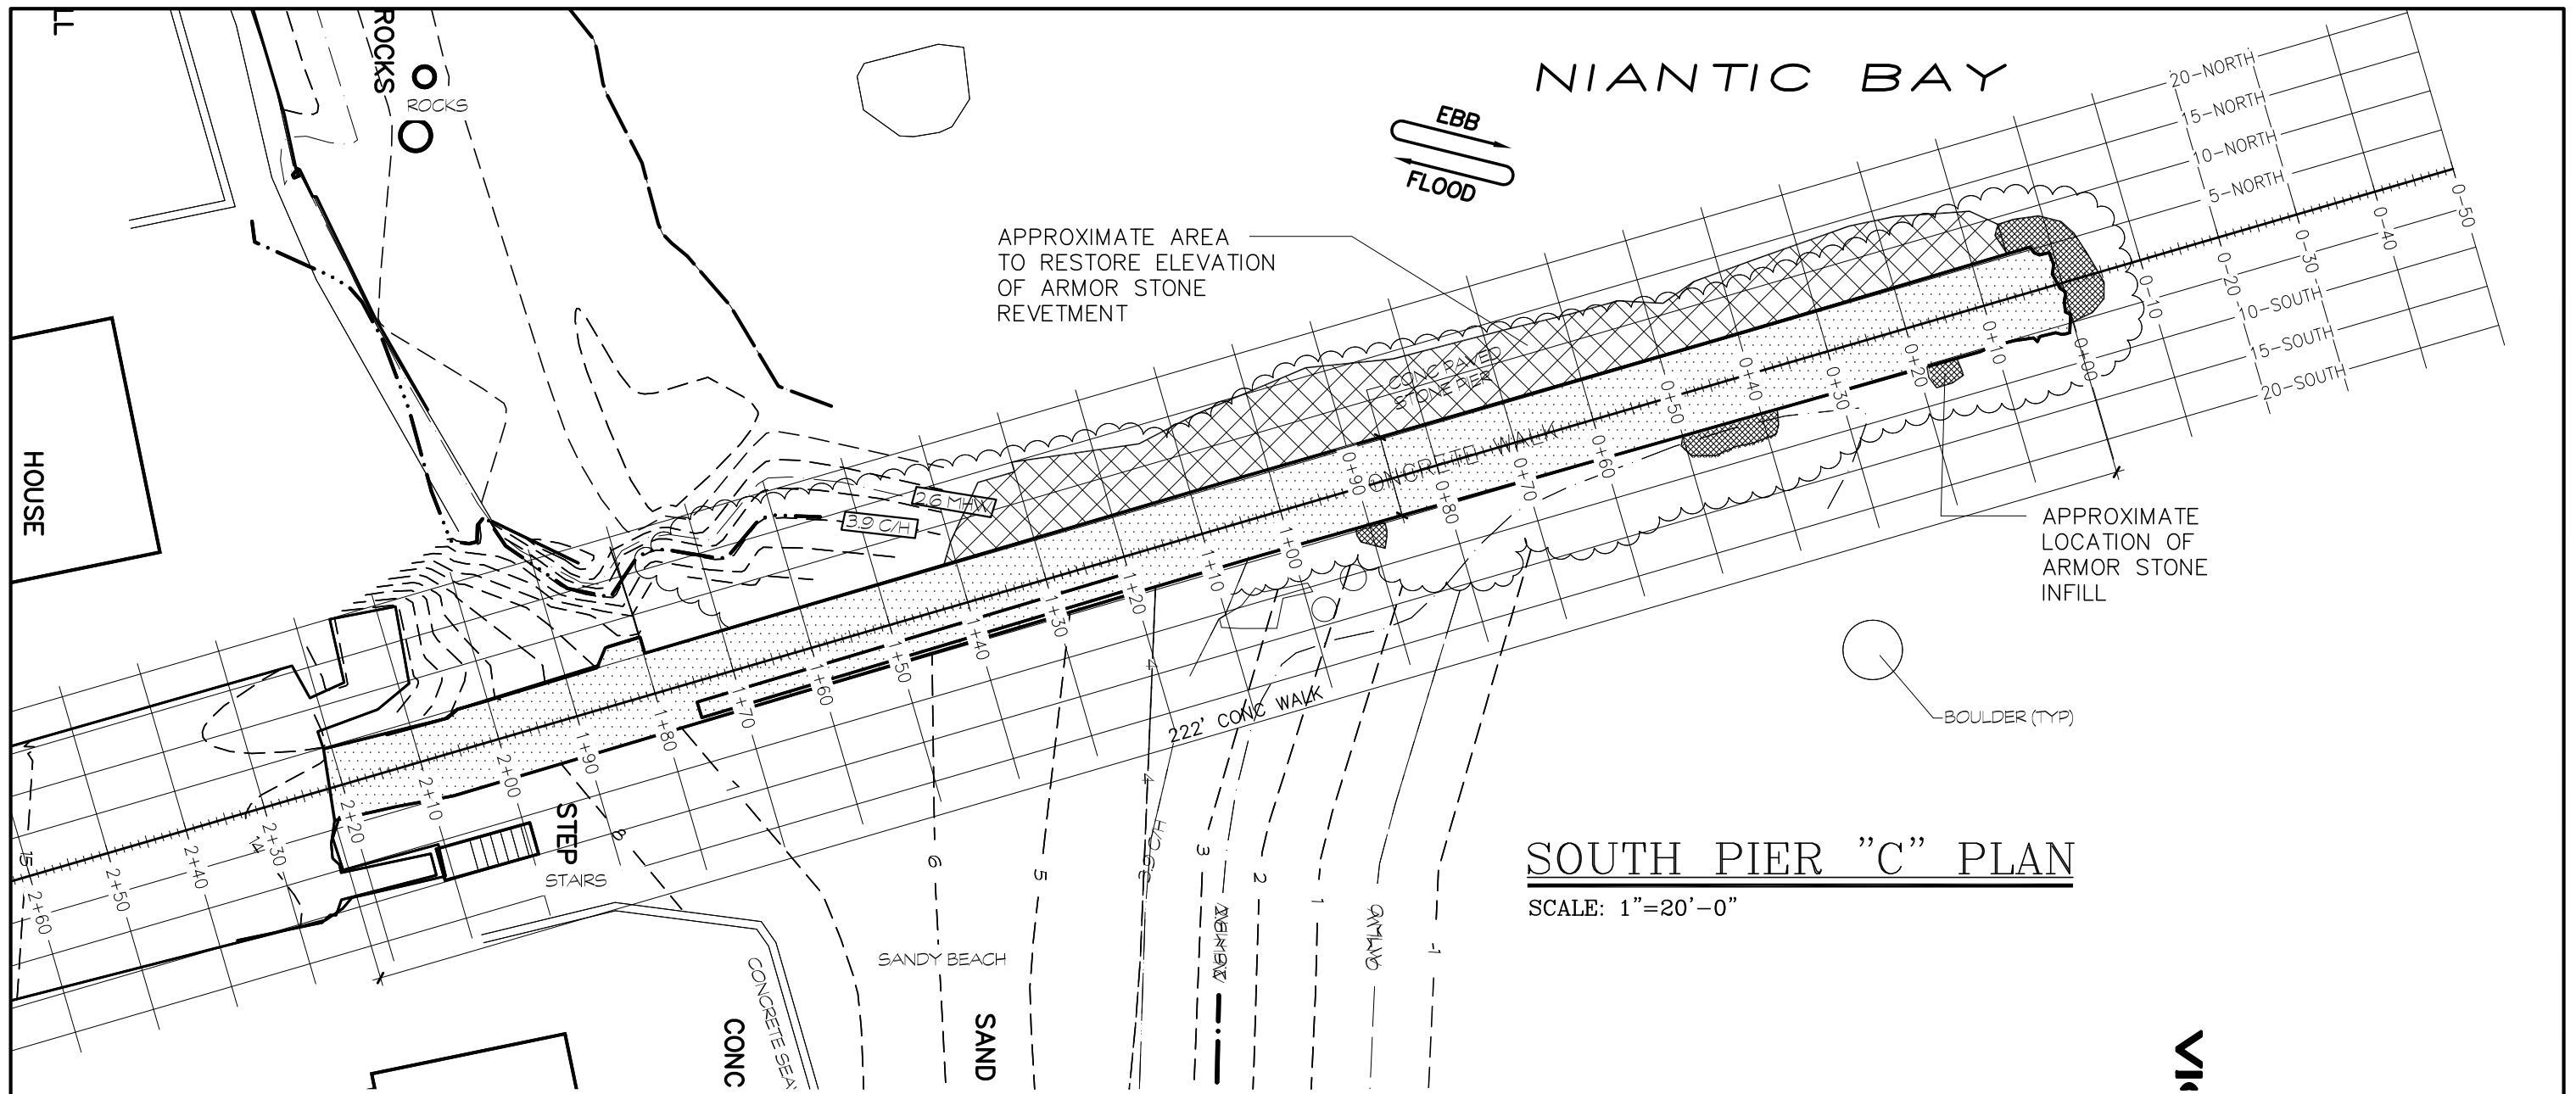
**SOUTH PIER "C" PLAN**  
 SCALE: 1"=20'-0"

All piers have undergone some degree of settlement. The most crucial settlement condition exists on the northern side of the South Pier "C" where the revetment appears to be up to 2 feet lower than the concrete paving. We attribute this to storm waves overtopping the groin from the south predominate wave fetch direction with the subsequent removal of the sands beneath the northern revetment. Continued wave action will jeopardize the stability of the groin and we would recommend restoring the height of this with armor stone as of size and conditions noted previously. This work should be undertaken with the next 5 years to safeguard this pier.

**Enhance Armor Stone:** For Pier C only - Full permit and raise stone on North Side of South Pier per SK2

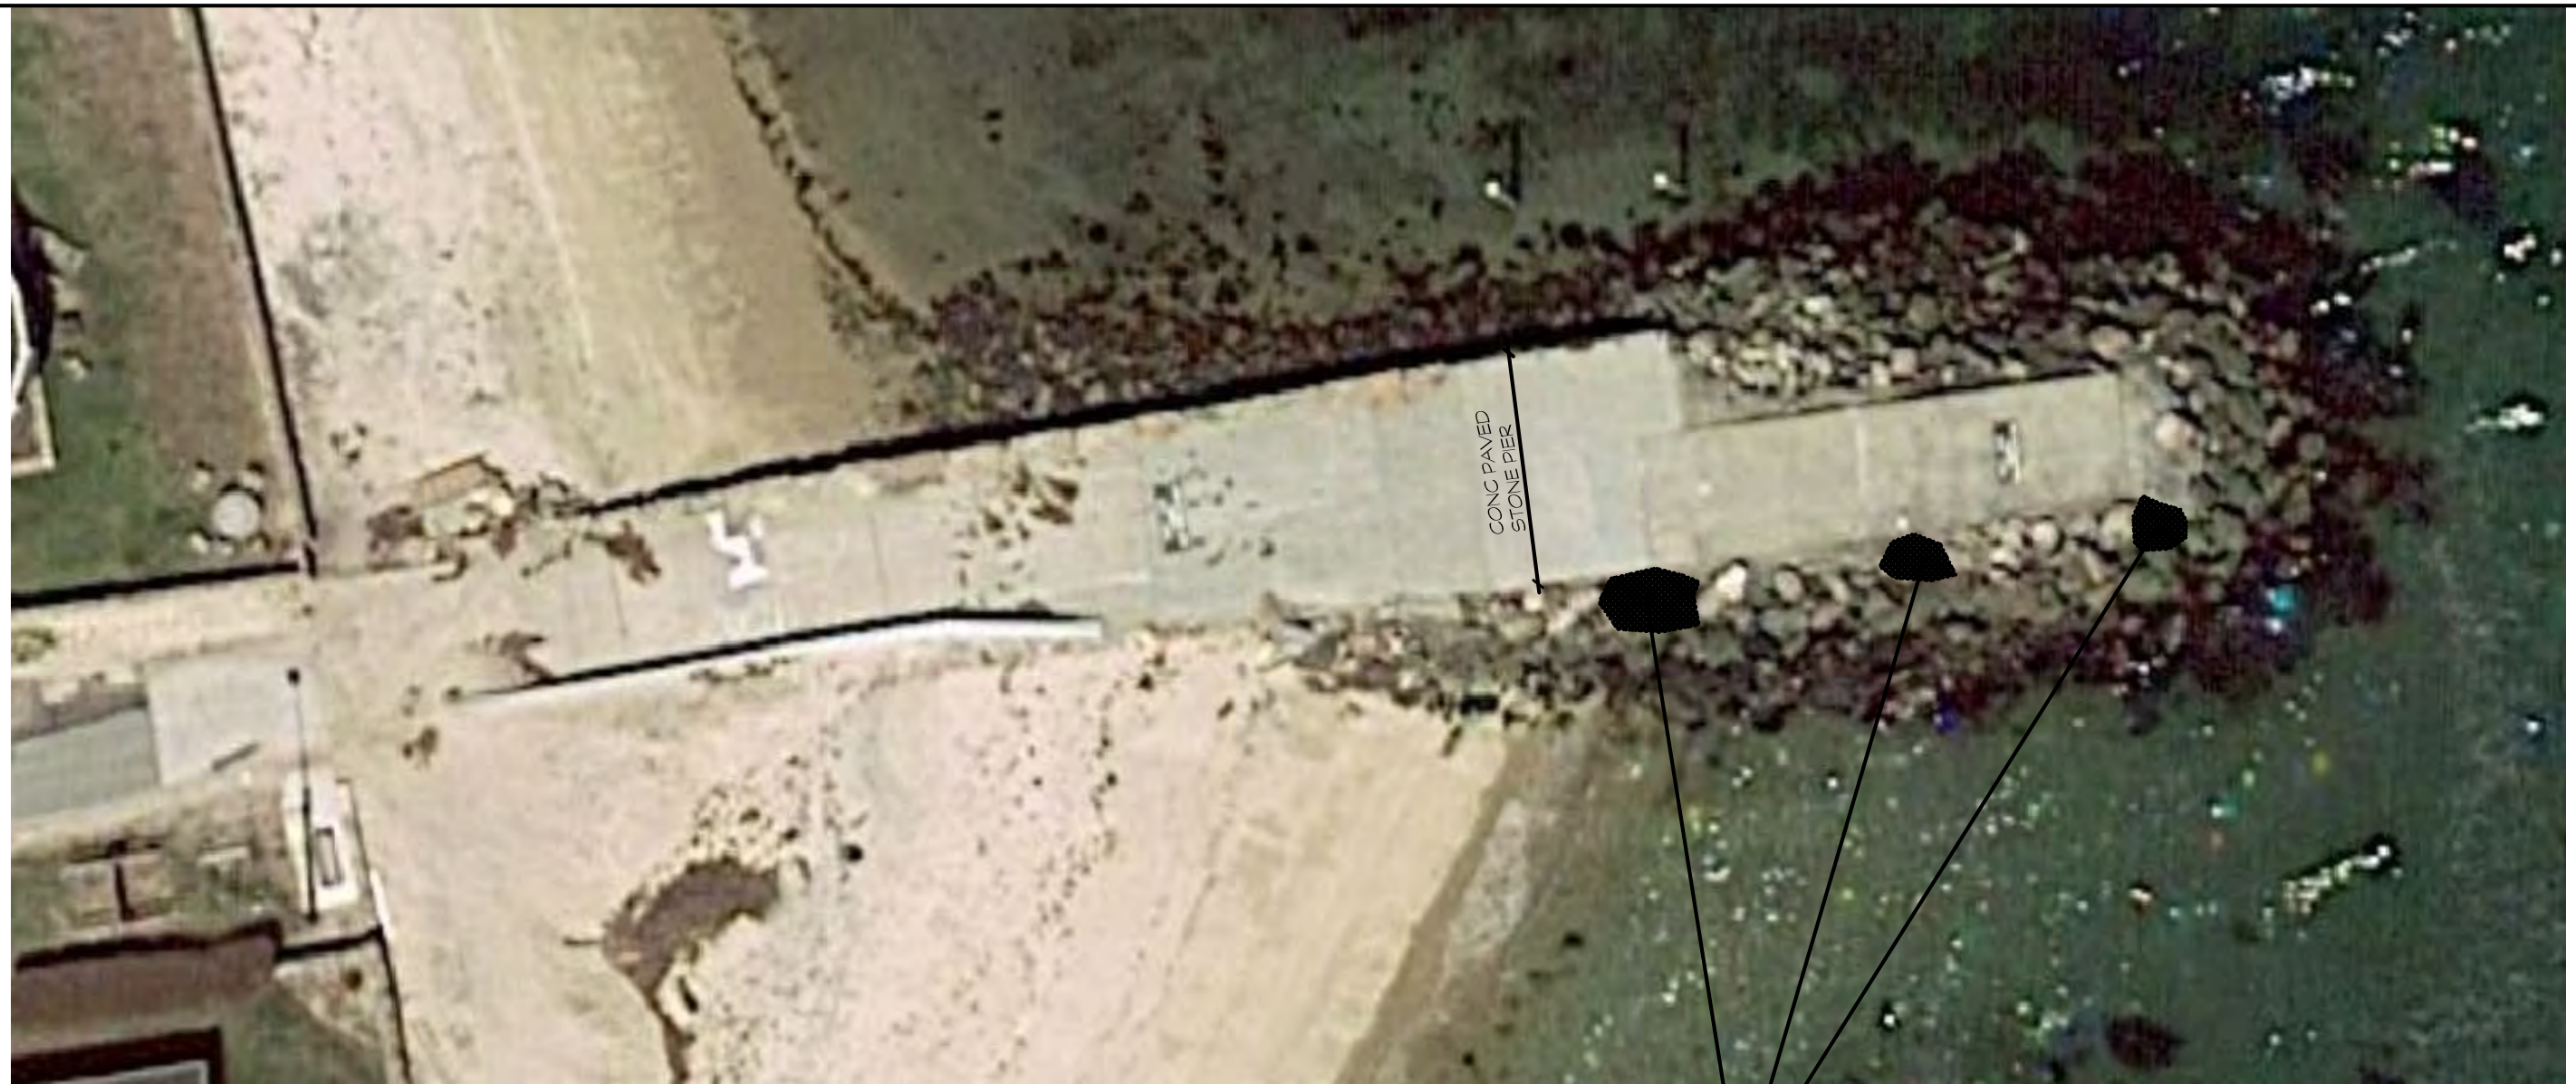
## PIER "D" PLAN

APPROXIMATE  
LOCATION OF  
ARMOR STONE  
INFILL

**Repair Armor Stone:** Repair Pockets of Missing Stone as shown on SK sheets for current repair and anticipate 20 tons for future repairs.

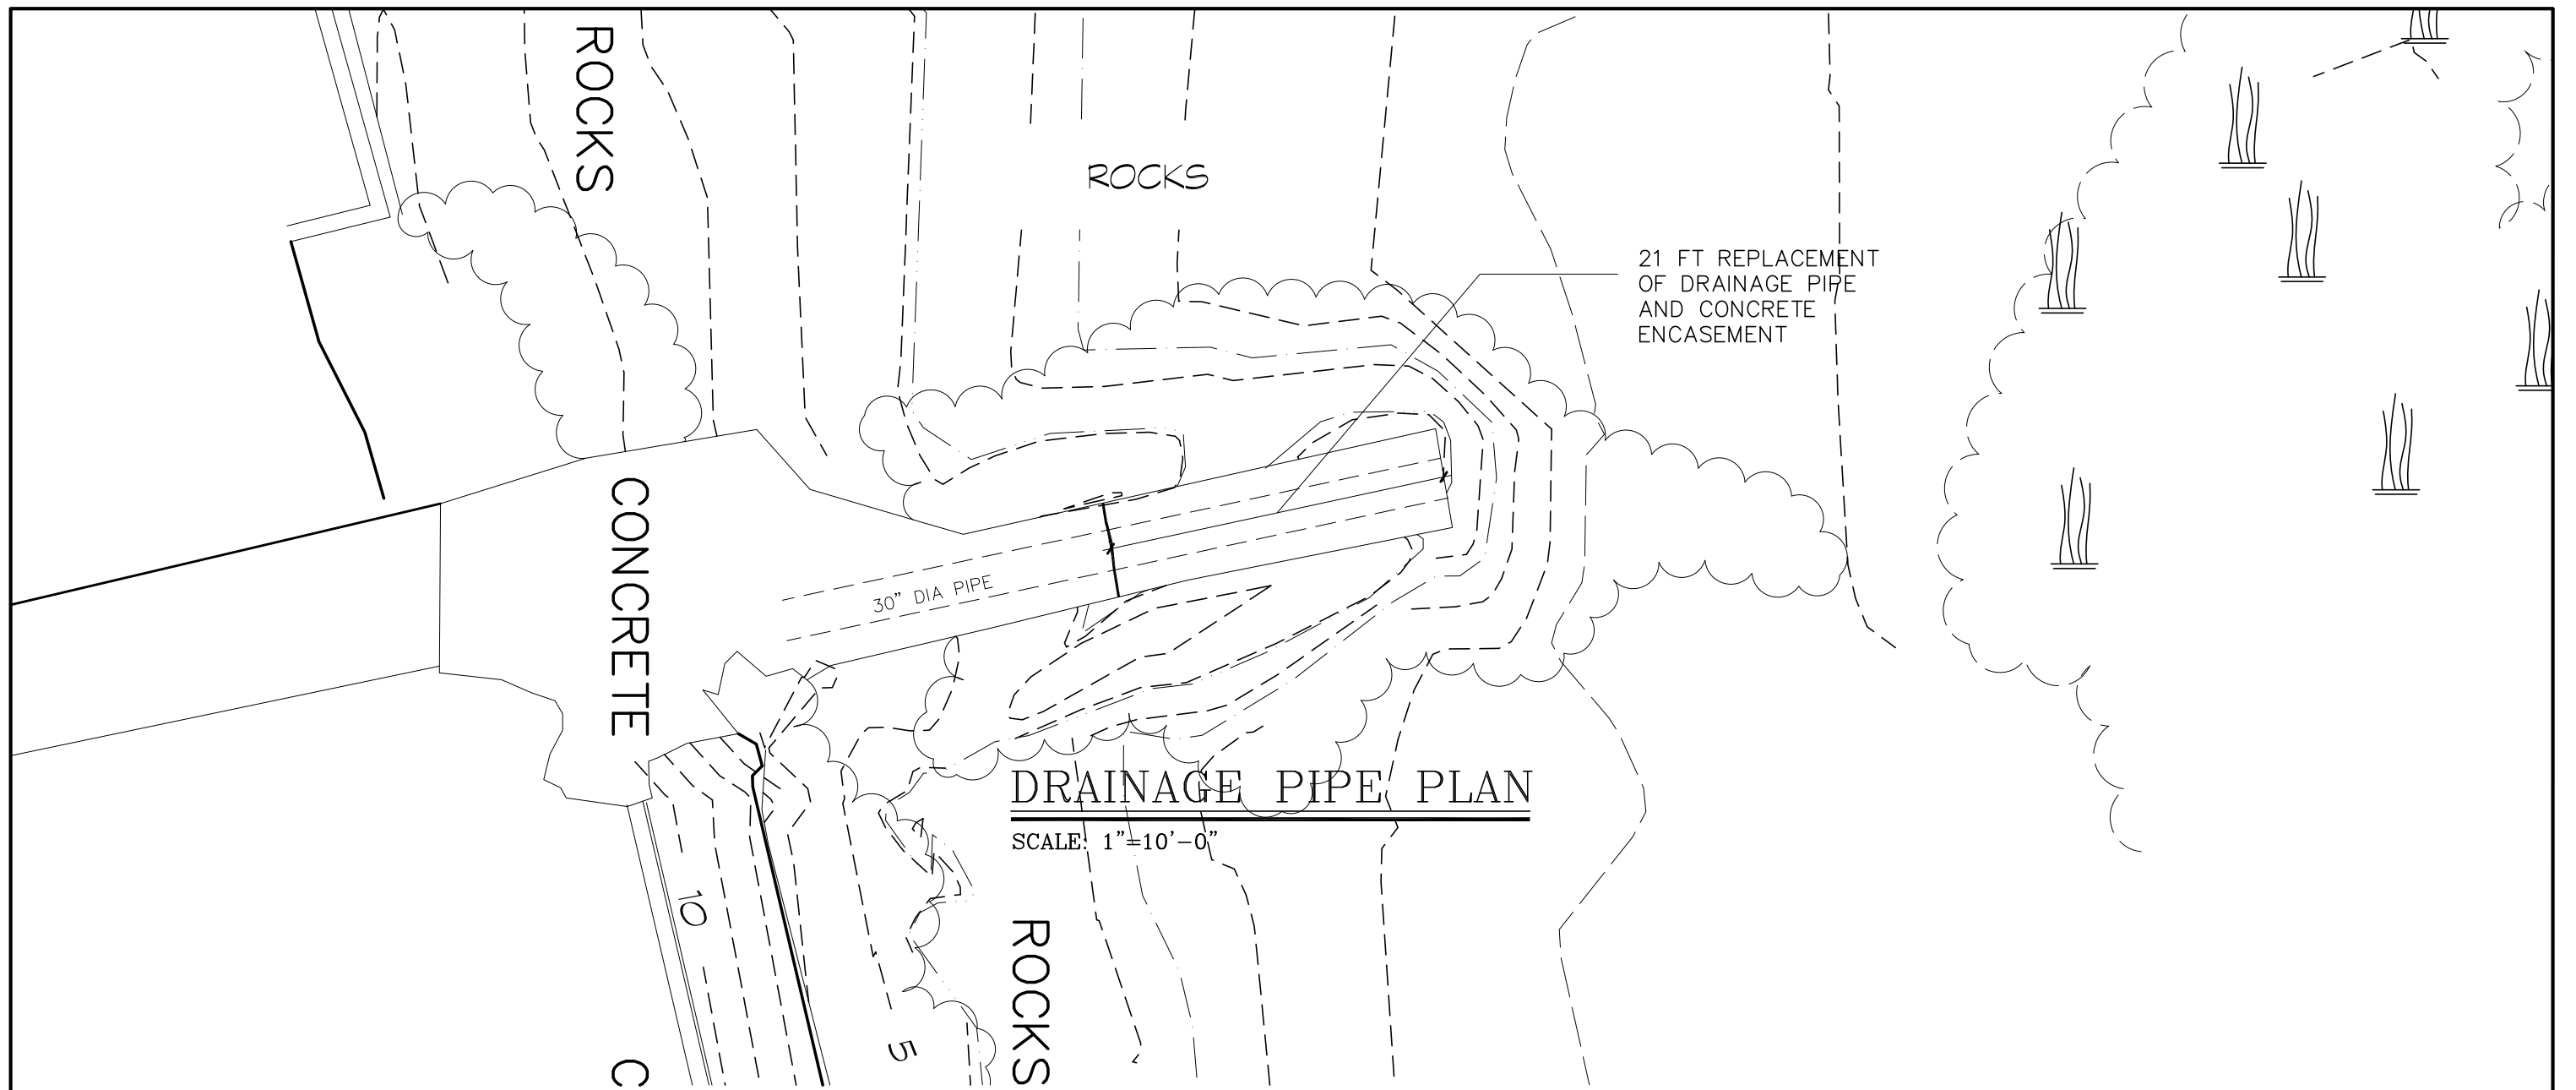
<b>DRAINAGE PIPE CONDITION ASSESSMENT</b>	
<b>BLACK POINT BEACH ASSOC. NIANTIC, CT</b>	
DATE: 12AUG20	DWG. NO.
PROJECT: #20113	<b>SK4</b>
SCALE: AS SHOWN	
DRAWN BY: CCB	
CHECKED BY:

With regard to the drainage pipe it would be advisable to apply for a Certificate of Permission immediately in order to preserve the right to maintain the pipe as needed. The pipe is in a delicate situation because the end section, a length of approximately 8 feet, has already become disjointed and has rotated, in position, approximately 30° counterclockwise. The system is still functional and therefore would be eligible for this maintenance work under the COP.

**Pipe Repair:** For Drain Pipe only - COP permit and replace last 21 feet of pipe and encasement.
