# CONDITIONS ASSESSMENT OF WATERFRONT STRUCTURES

Black Point Beach Club Association

East Lyme, CT USA

Revised March 24, 2026

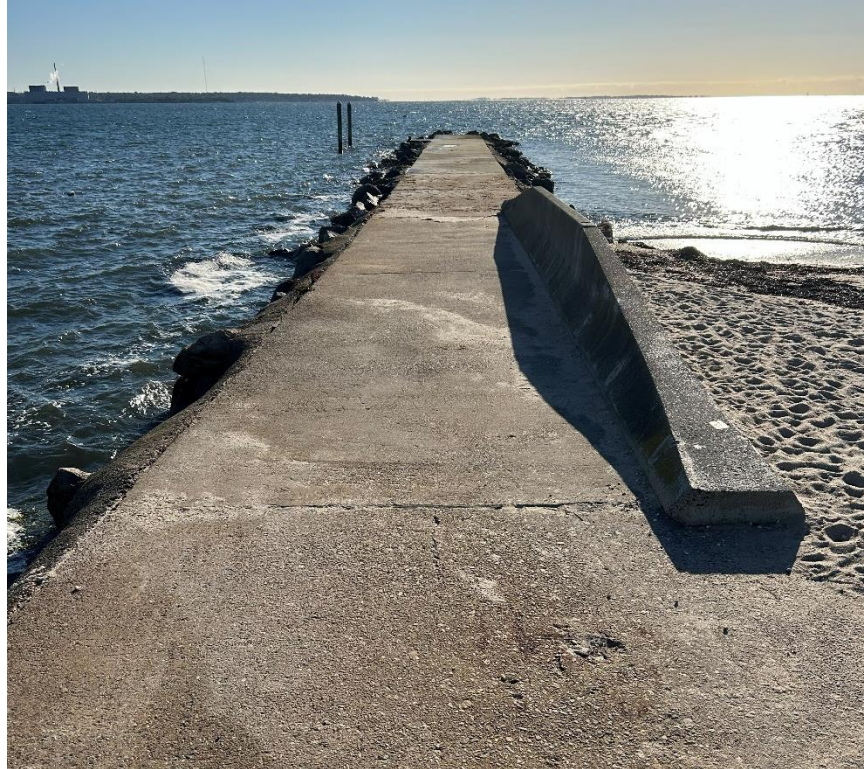
The Nehantic Pier off the extension of Nehantic Road extending approximately 281 feet into Niantic Bay was generally found to be in FAIR condition overall, though certain portions of the concrete walkway were found to be in POOR condition. The ramp landing platform for access to the float was observed to be in SERIOUS to CRITICAL condition. The pier consists of cast-in-place concrete slabs supported by a cut granite block foundation with armor stone protection along both sides. The concrete deck exhibits moderate cracking, surface scouring, and localized settlement, most notably along the North side where loss of bearing support and visible joint separation have developed. Evidence of previous grout injection and concrete repair remains visible and mostly intact, although incomplete bonding and open seams allow groundwater infiltration and continued void formation beneath the slabs.

**Photo 1: Nehantic pier**

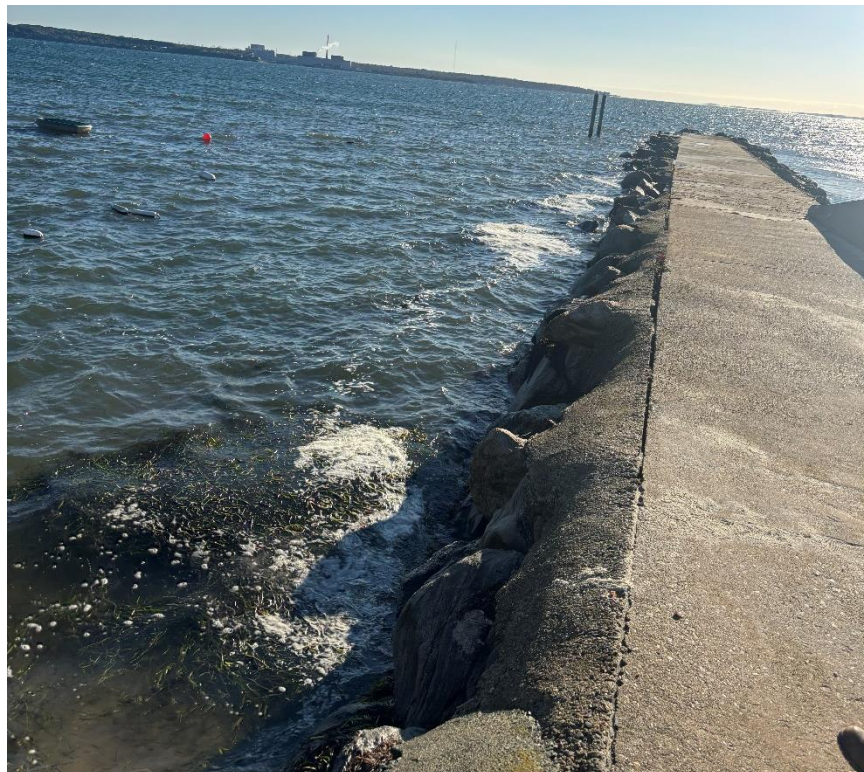
**Photo 2: Nehantic pier North armor stone**

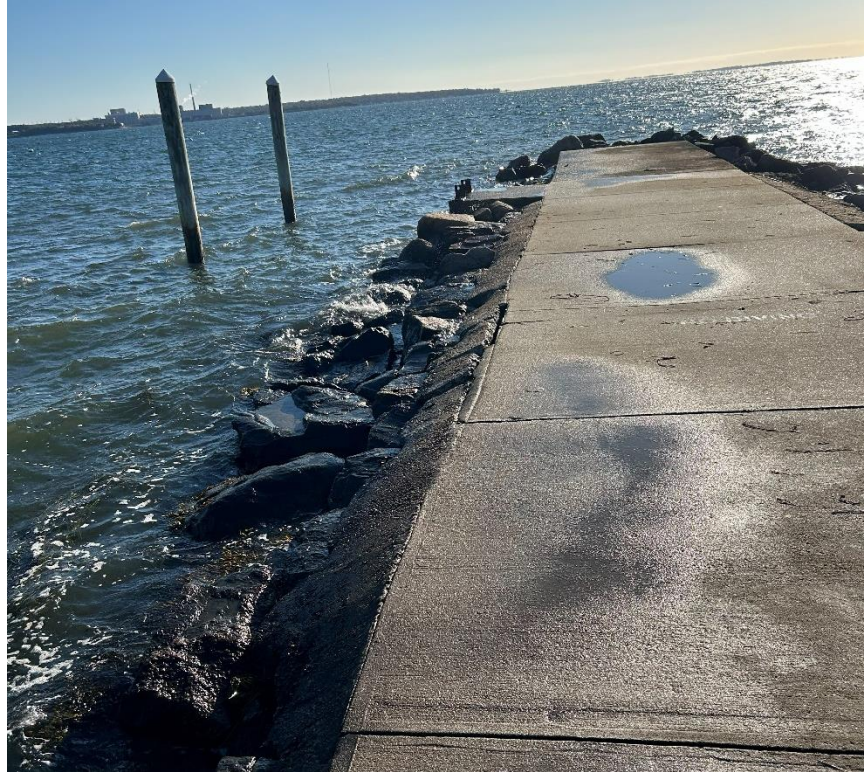
**Photo 3: Nehantic pier North side end**

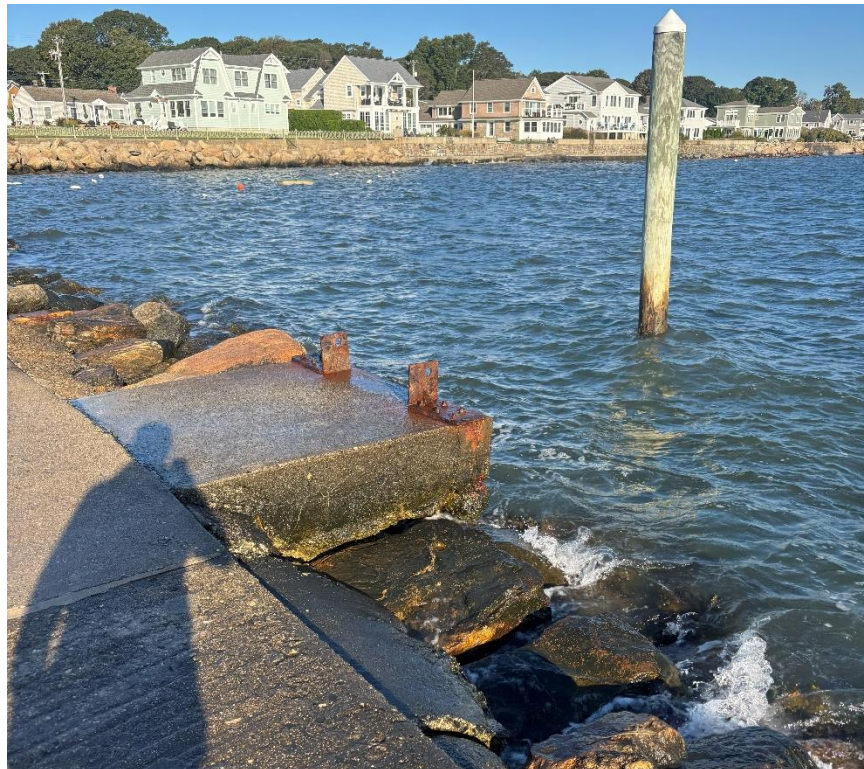
Several armor stones have shifted or been lost due to direct wave exposure, leaving voids beneath the concrete walkway and exposing the granite foundation toe. The end slab remains stable and in SATISFACTORY condition, while the two intermediate slabs show downward deflection and joint cracking consistent with loss of support. The ramp landing platform at the North end is severely undermined and cantilevered, with limited remaining support, and should be repaired IMMEDIATELY with pedestrian access restricted until restoration is complete. To restore long-term stability, displaced armor stones should be reset and supplemented, undermined voids should be grout injection filled, and the two cracked slabs replaced. The ramp landing platform should be reconstructed and the surrounding area supplemented with new armor stone to protect from further scour.

**Photo 4: Nehantic pier partially cantilevered ramp landing platform**

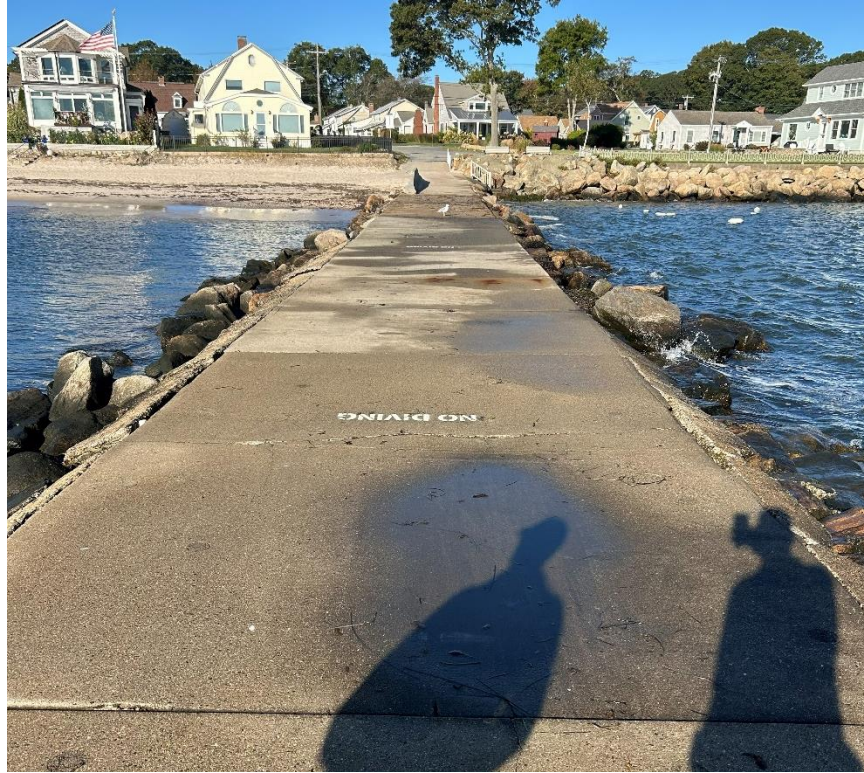
**Photo 5: Nehantic pier deteriorated intermediate concrete slabs**

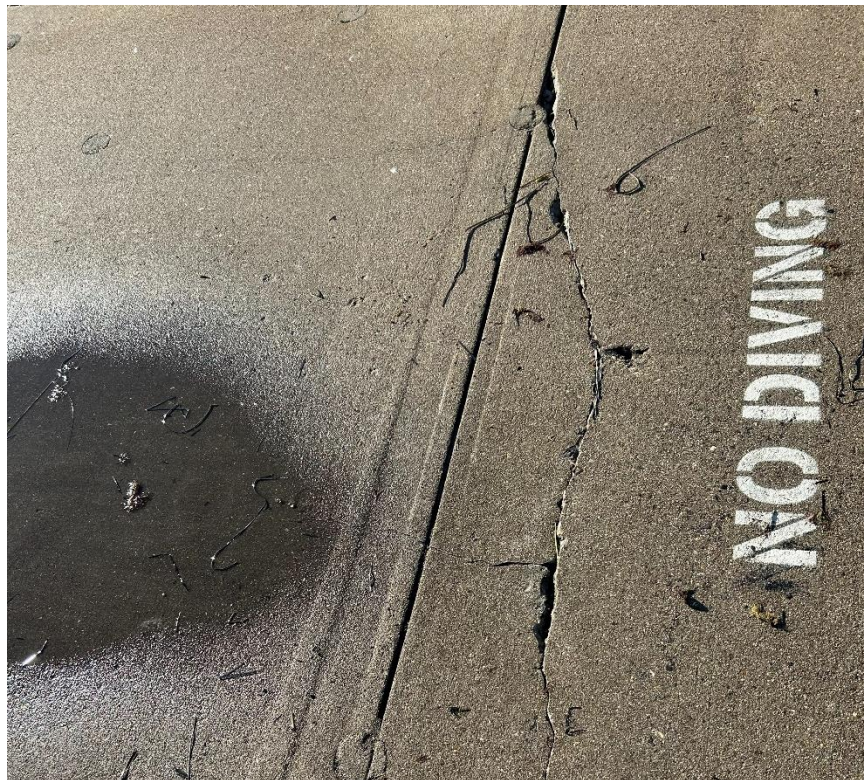
**Photo 6: Nehantic pier cracked concrete**

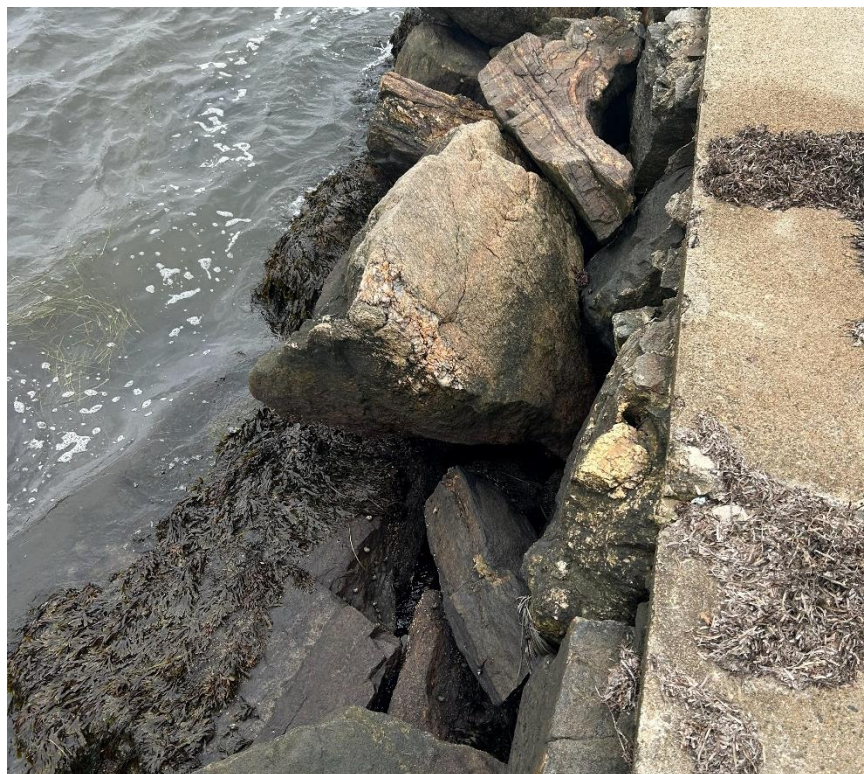
**Photo 7: Nehantic pier displaced armor stone**

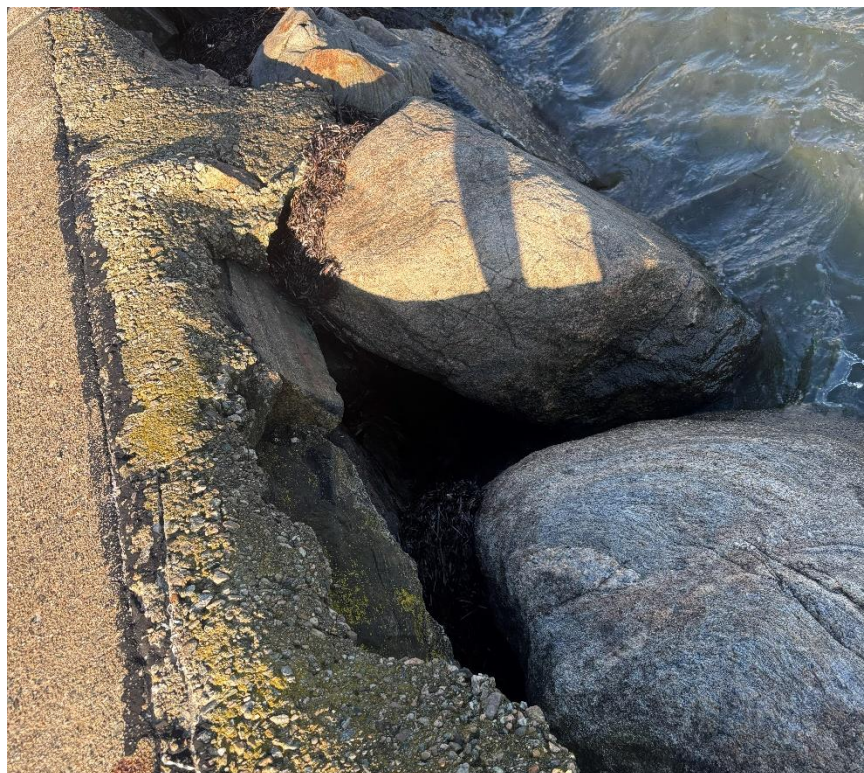
**Photo 8: Nehantic pier void in stone foundation**

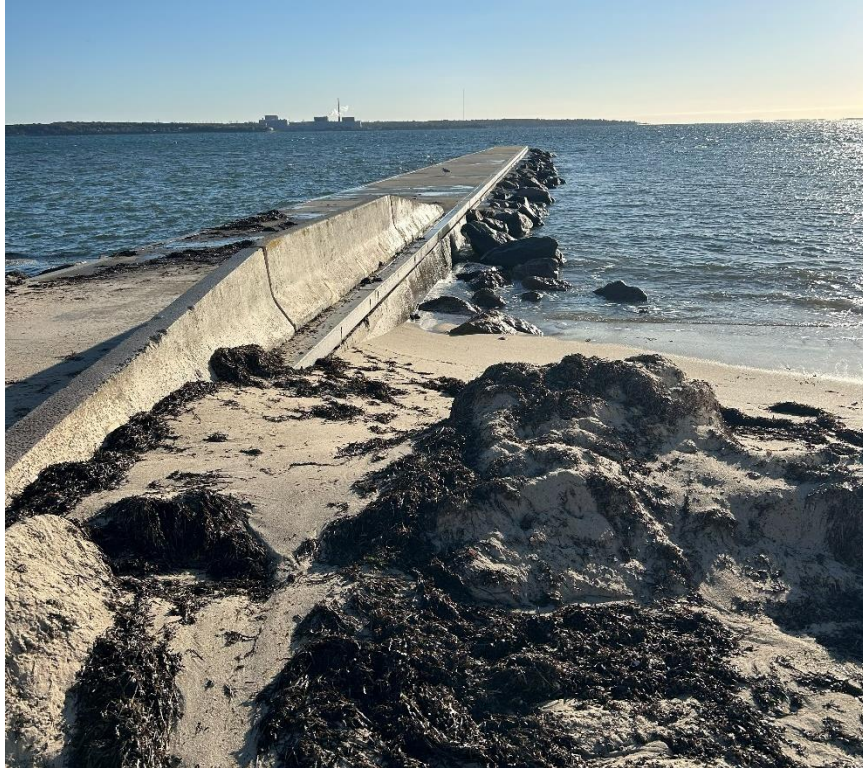
The Indianola Steel Pier between Indianola Road/Cahill Way and White Cap Road extending roughly 260 feet into Niantic Bay was observed to be in SATISFACTORY to GOOD condition overall, with only minor surface deterioration on the steel sheet pile. This pier consists of a concrete-capped steel sheet-pile wall with concrete and stone infill and armor stone protection along the South side. The concrete walkway remains level and intact with minimal cracking and effective joint sealant throughout, while the steel sheet piles exhibit only light surface corrosion in the splash zone. Armor stone alignment and interlock remain tight, showing no measurable settlement or rotation.

**Photo 9: Indianola steel pier**

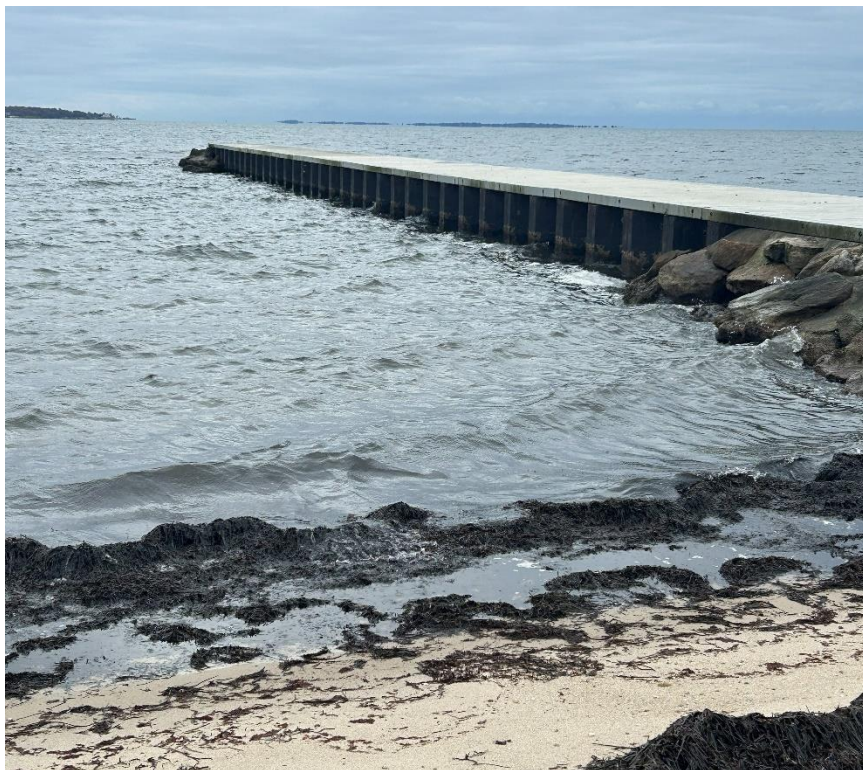
**Photo 10: Indianola steel pier North side**

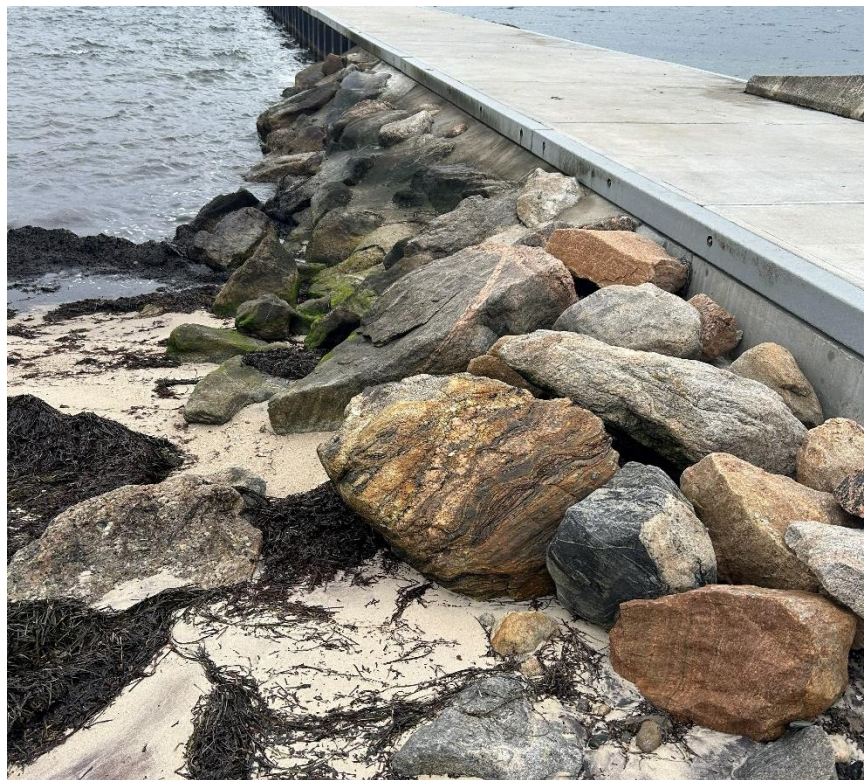
**Photo 11: Indianola steel pier North side armor stone**

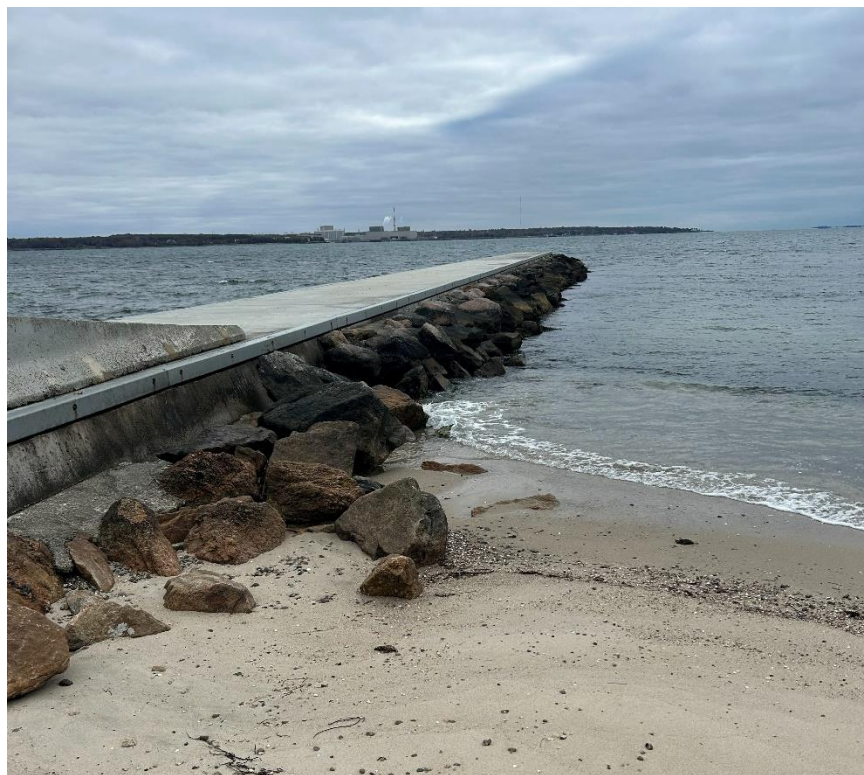
**Photo 12: Indianola steel pier South side**

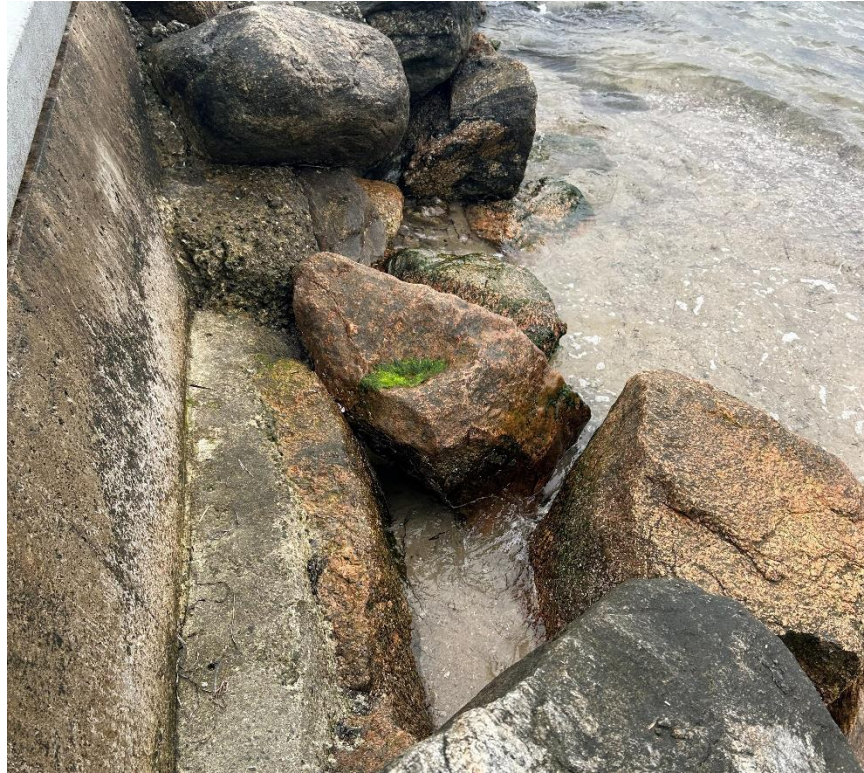
**Photo 13: Indianola steel pier displaced armor stones South side**

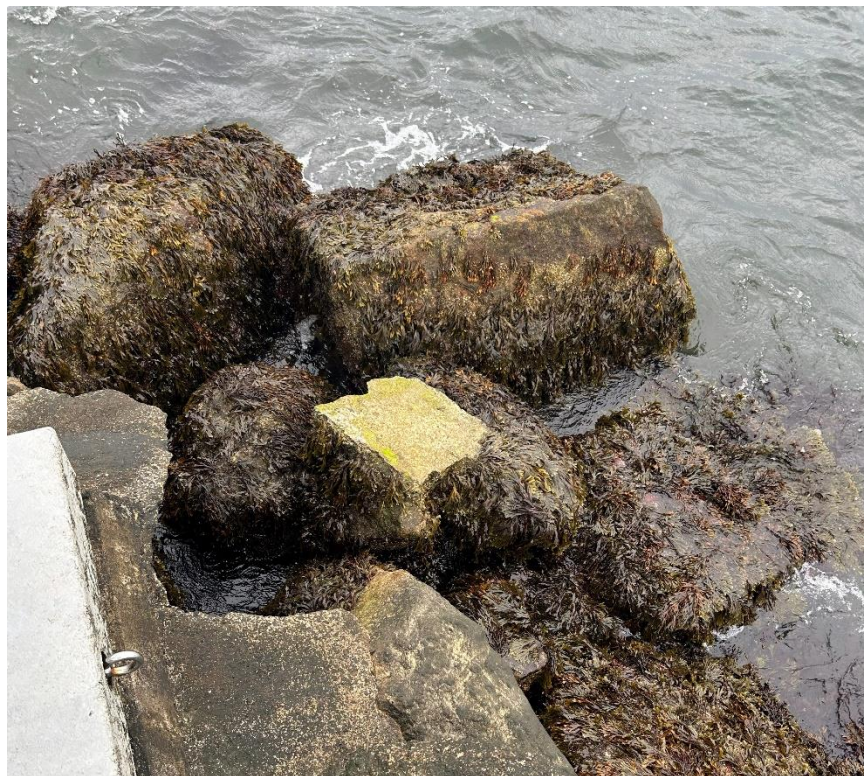
**Photo 14: Indianola steel pier shifted armor stones Southeast corner**

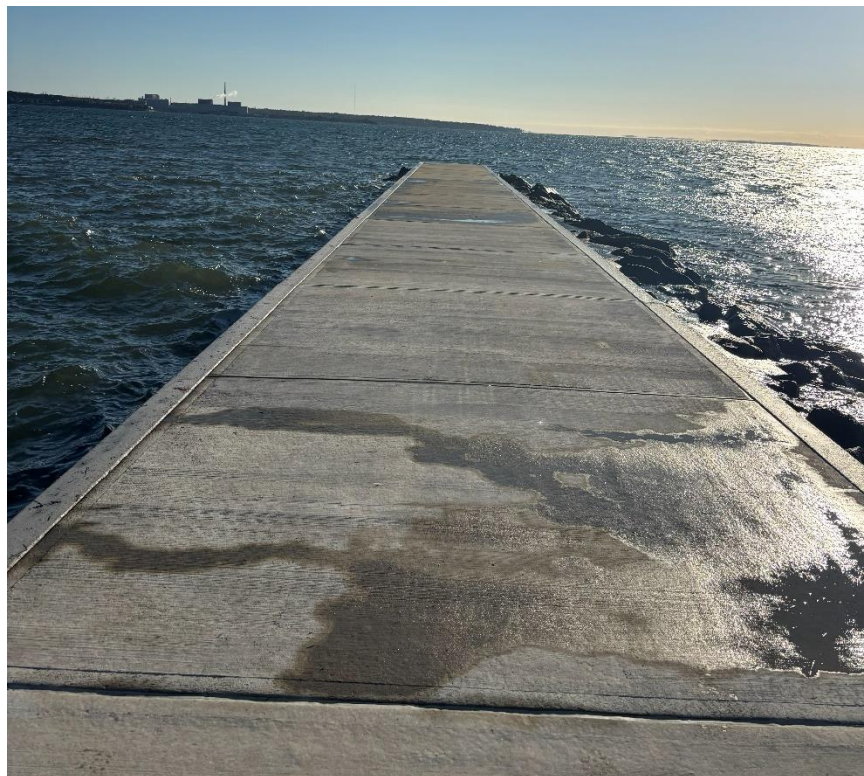
**Photo 15: Indianola steel pier concrete walkway**

inspection and light maintenance of surface cracking and rust are recommended to preserve long-term serviceability. This light maintenance may include concrete filling and joint sealing as cracks develop on the walkway and surface coating, patching, and individual pile replacement if necessary, on the steel sheet pile as corrosion becomes severe. No repairs are required at this time, and the pier is expected to remain in satisfactory condition for at least the next 15–20 years with proper maintenance.

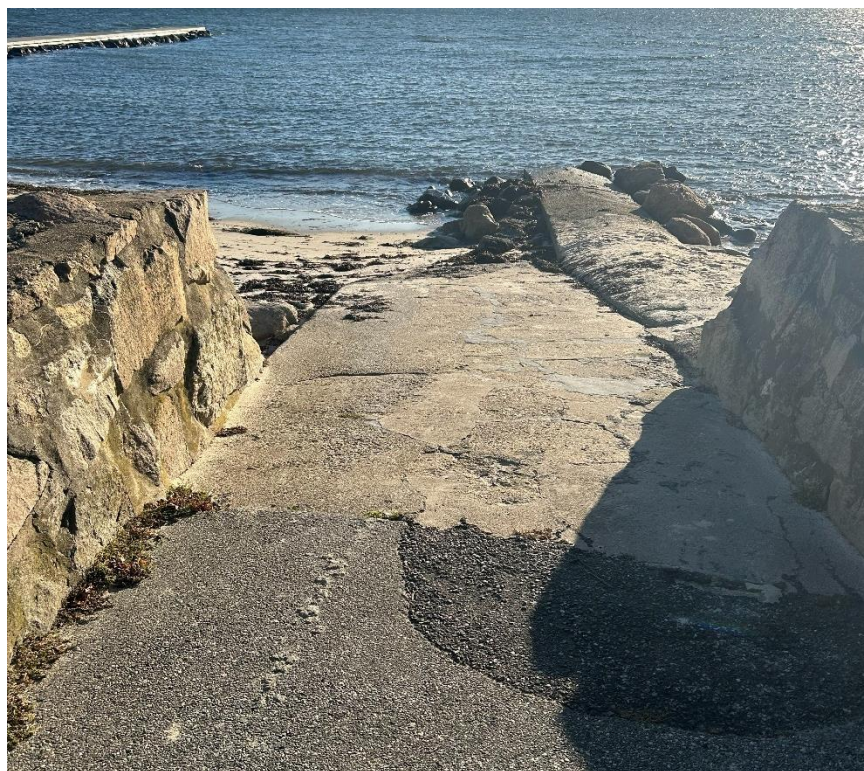
The White Cap Access Way drainage structure off the extension of White Cap Road extending approximately 60 feet into Niantic Bay was observed to be in POOR to SERIOUS condition overall, though still marginally serviceable. The structure consists of a 30-inch pre-cast concrete pipe encased within a deteriorated concrete headwall and cap. The final 10–12 feet of pipe and encasement are broken, settled, and misaligned, with visible joint separation and rotation at the discharge end. Severe cracking extends approximately 12 feet back from the outlet, and the last 20+ feet of the encasement show clear signs of structural failure and settlement consistent with the conditions noted in the prior GNCB report.

**Photo 16: White Cap access way**

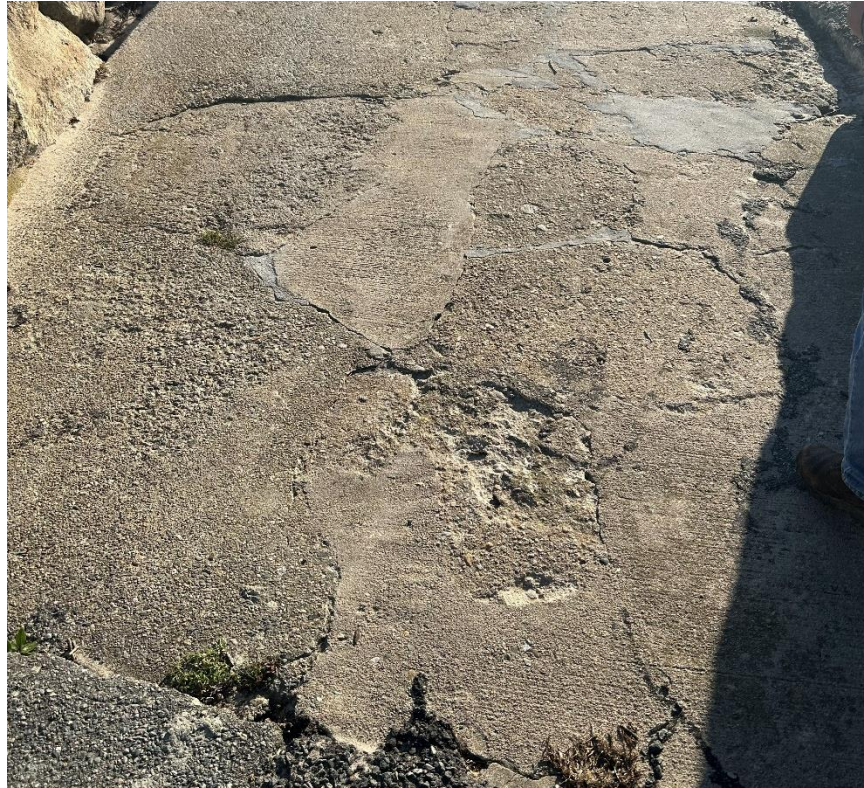
Multiple concrete patches indicate at least four or five past repair attempts, all showing renewed deterioration. Ice damage and surface scaling were observed along the upper quadrant, while localized washout beneath the discharge end confirms ongoing undermining and loss of support. Although still functioning under normal flow, this structure is nearing the end of its service life and may fail during heavy runoff or storm events. Replacement of the disjointed pipe section and encasement back to sound connection, along with resetting and supplementing displaced armor stone, is recommended in the near term to restore full drainage function and prevent failure.

**Photo 17: White Cap access way deteriorated concrete apron**

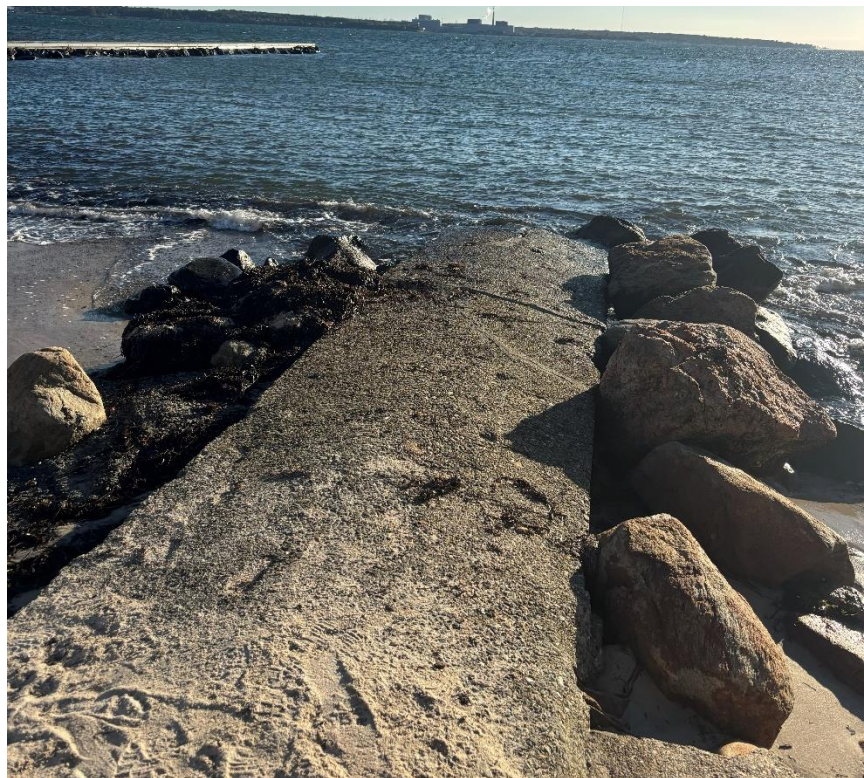
**Photo 18: White Cap access way drainage pipe encasement**

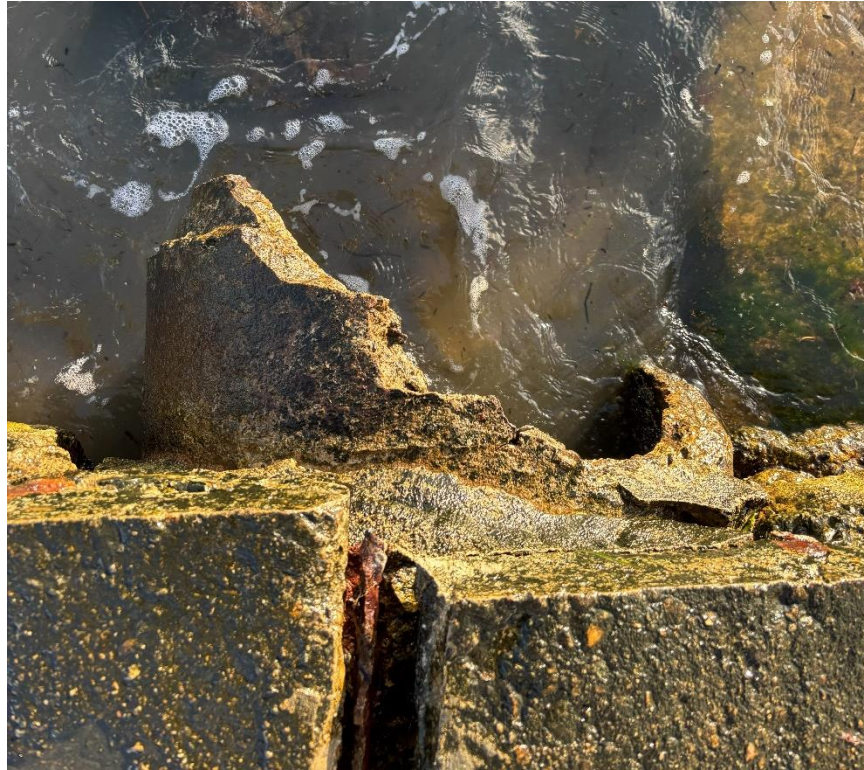
**Photo 19: White Cap access way drainage pipe end**

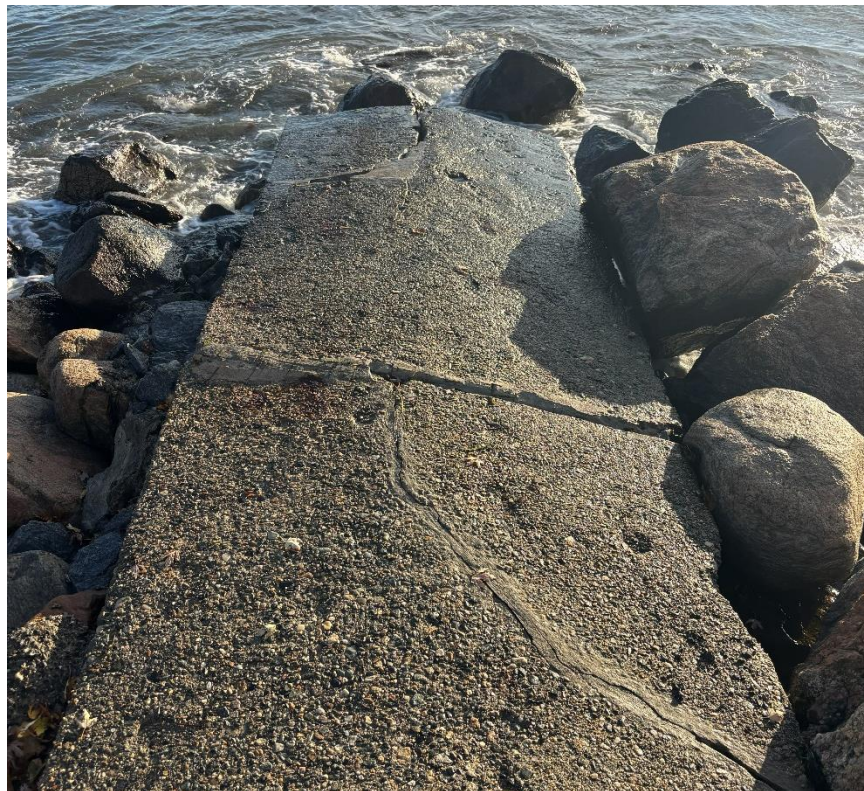
**Photo 20: White Cap access way cracks in drainage pipe encasement**

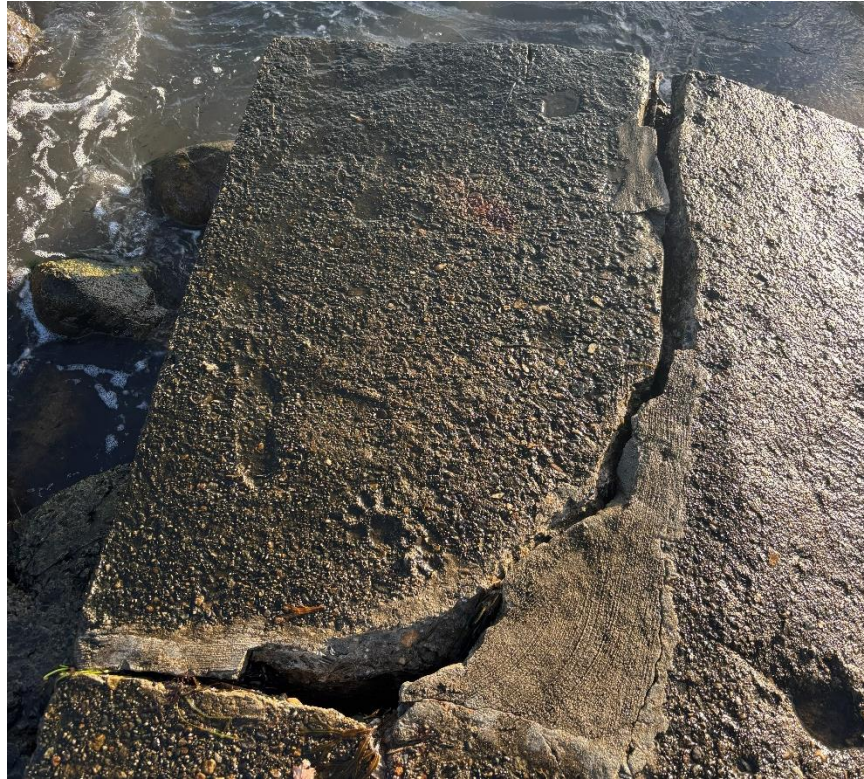
**Photo 21: White Cap access way broken off encasement end**

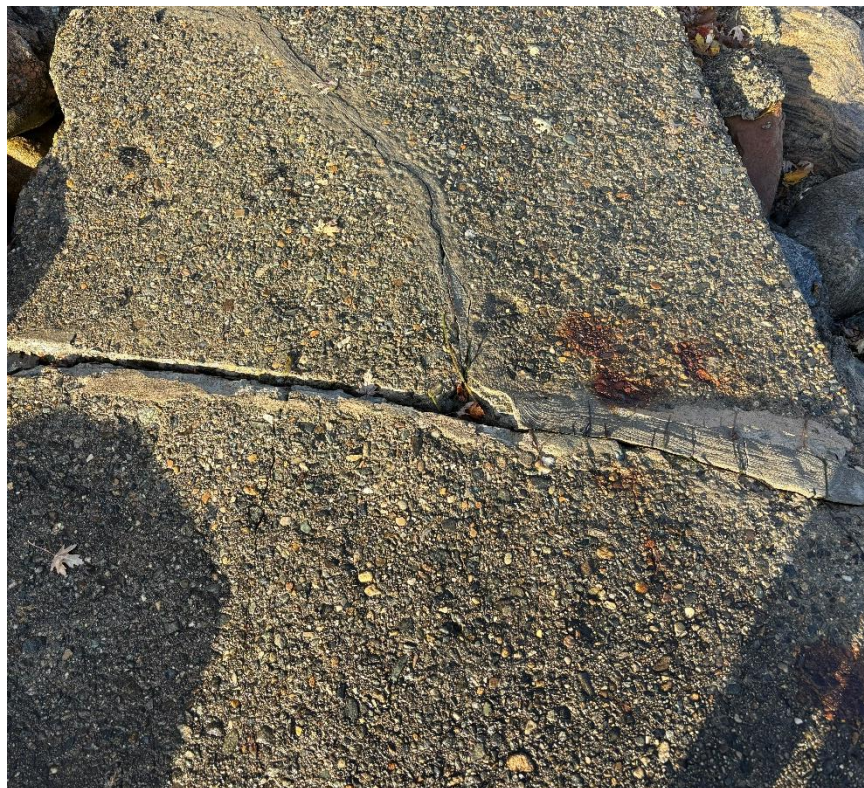
**Photo 22: White Cap access way presumed pipe break location**

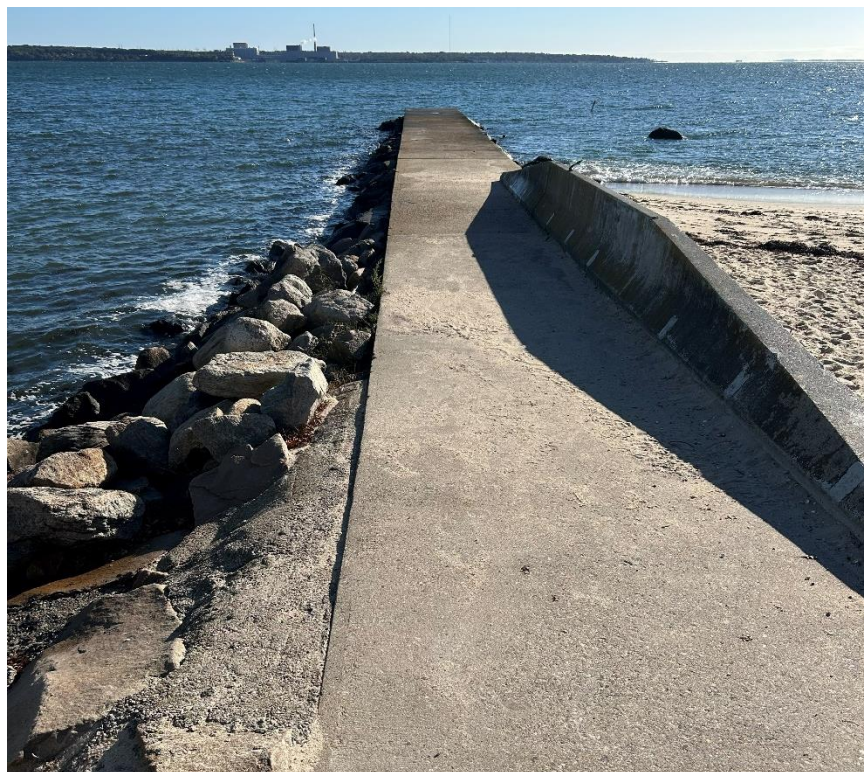
The Sea Breeze Pier off the extension of Sea Breeze Avenue extending approximately 220 feet into Niantic Bay was found to be in FAIR to POOR condition overall, with the Northeast corner classified as SERIOUS to CRITICAL. The pier consists of cast-in-place concrete slabs over a cut granite and rip-rap foundation with armor stone protection along both sides. The structure exhibits severe settlement ranging from approximately 6–18 inches along both sides and up to 24 inches on the North side, resulting in loss of bearing support beneath portions of the slab. Evidence of prior grout repair and localized concrete infill was noted throughout, particularly along the North side where grout was used as a temporary stabilization measure over unfilled voids.

**Photo 23: Sea Breeze pier**

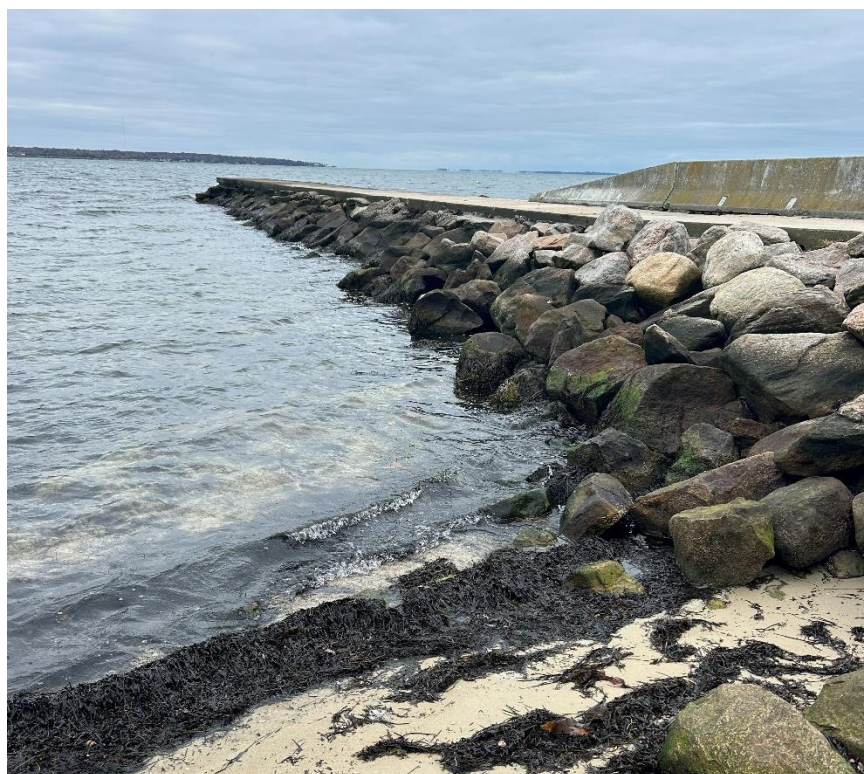
**Photo 24: Sea Breeze pier North side armor stone**

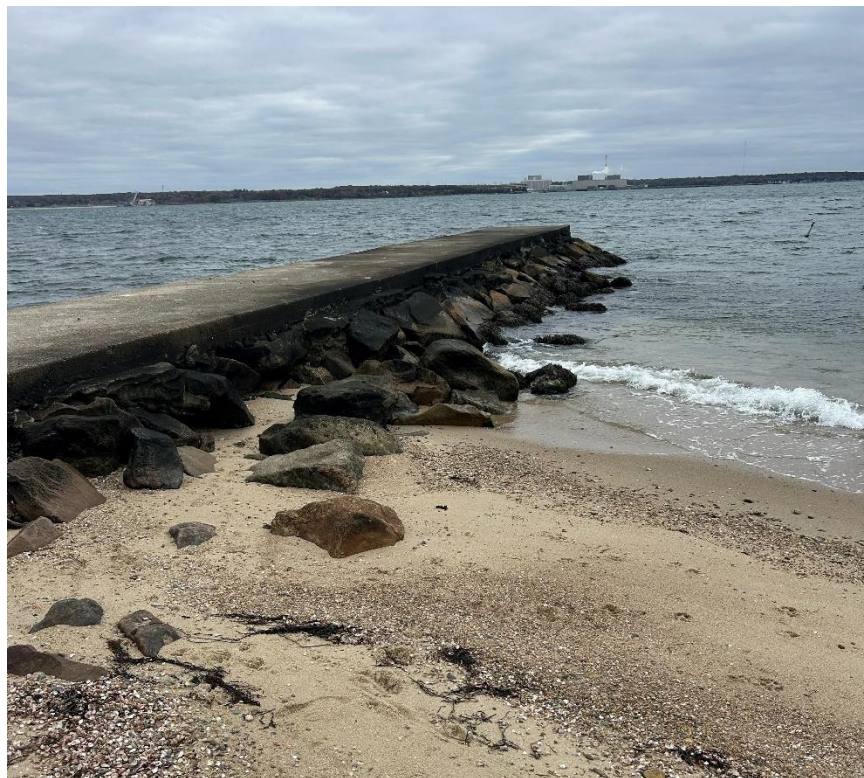
**Photo 25: Sea Breeze pier South side armor stone**

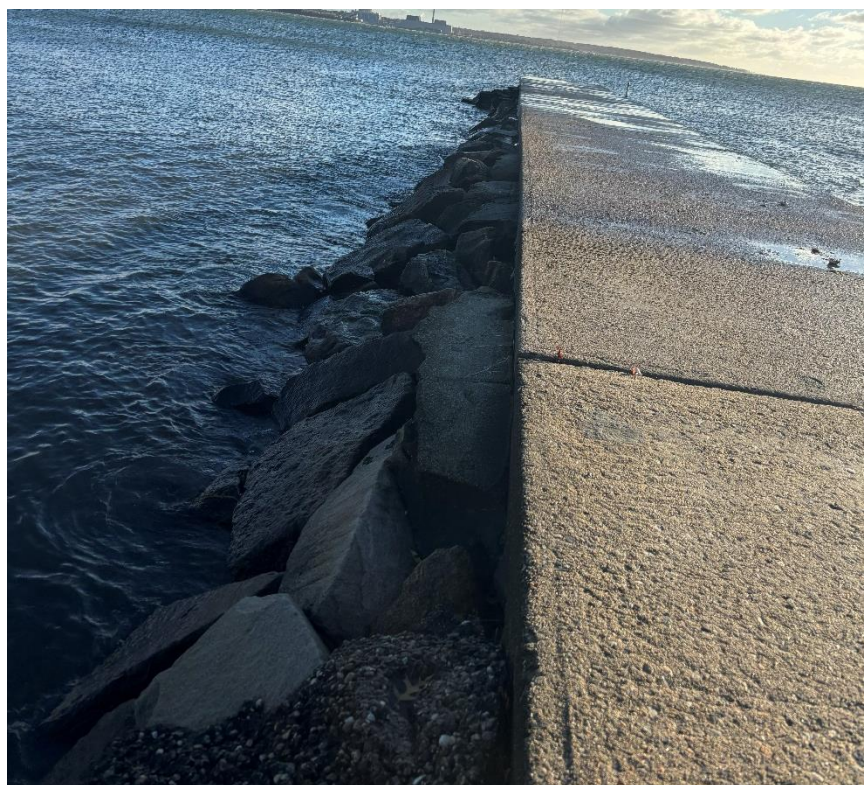
Several armor stones have shifted or are missing, reducing toe stability and allowing localized scour and ongoing settlement of the foundation. The concrete walkway remains serviceable but shows moderate cracking, surface scaling, and chipped corners near slab joints consistent with freeze-thaw distress and voiding below. The Northeast corner of the slab is partially cantilevered and unsupported, with visible separation from the underlying stone foundation. Temporary grout placement has slowed progression but does not provide adequate long-term stability. To restore durability, displaced armor stones should be reset and supplemented by at least 10% in total volume to reestablish slope geometry and grade elevation. Deteriorated concrete infill should be removed and replaced with flowable grout to restore uniform bearing, and open joints should be sealed to prevent infiltration. Without corrective action, continued settlement and partial failure are expected within the next five years.

**Photo 26: Sea Breeze pier North side armor stone settlement**

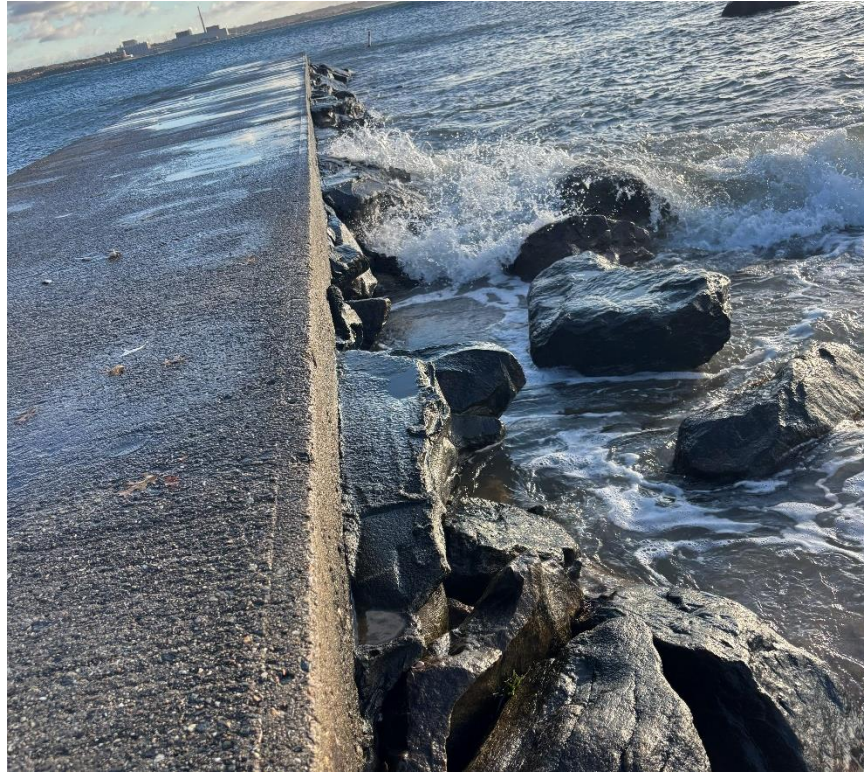
**Photo 27: Sea Breeze pier South side armor stone settlement**

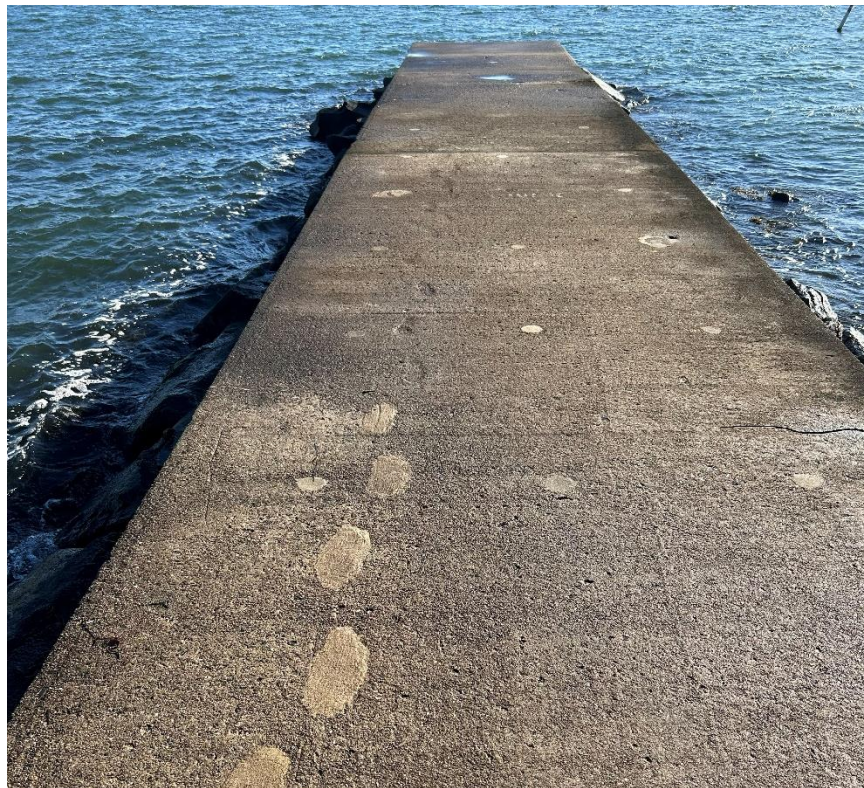
**Photo 28: Sea Breeze pier deteriorated concrete end slabs**

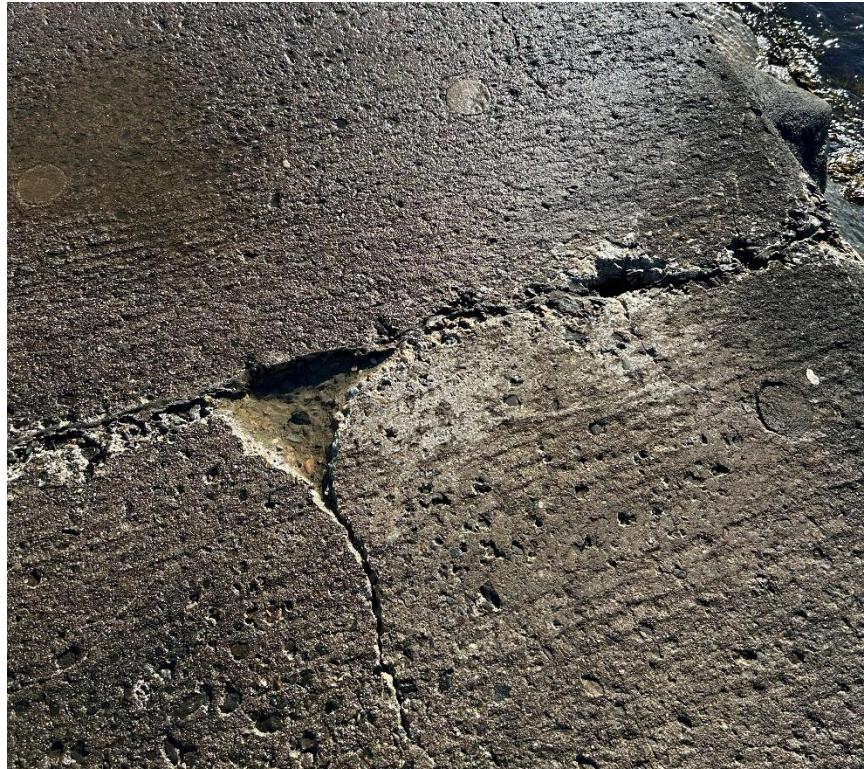
**Photo 29: Sea Breeze pier concrete crack formation**

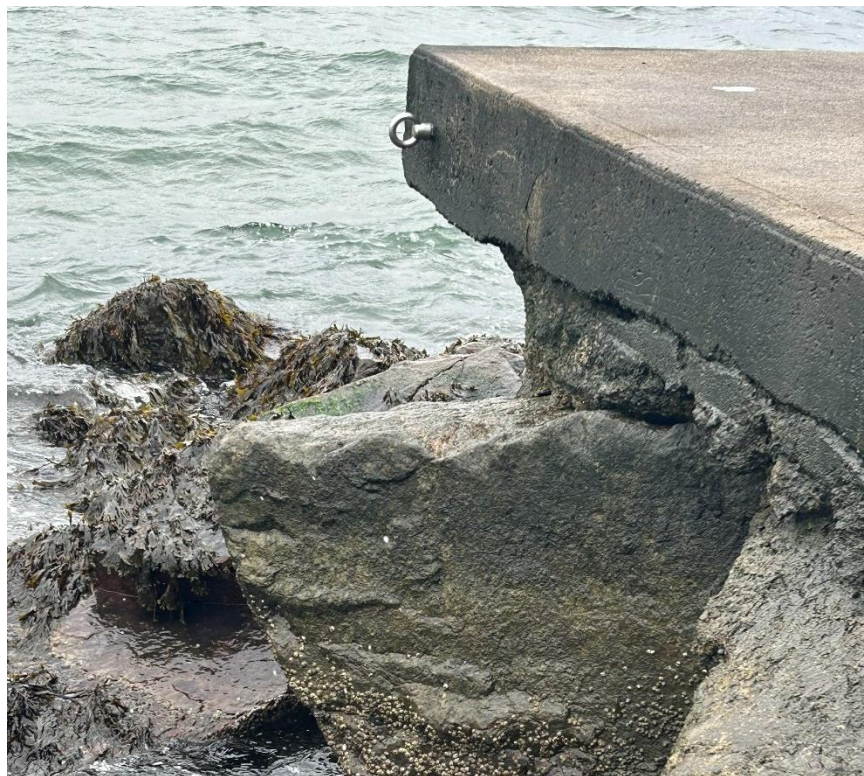
**Photo 30: Sea Breeze pier partially cantilevered Northeast corner**

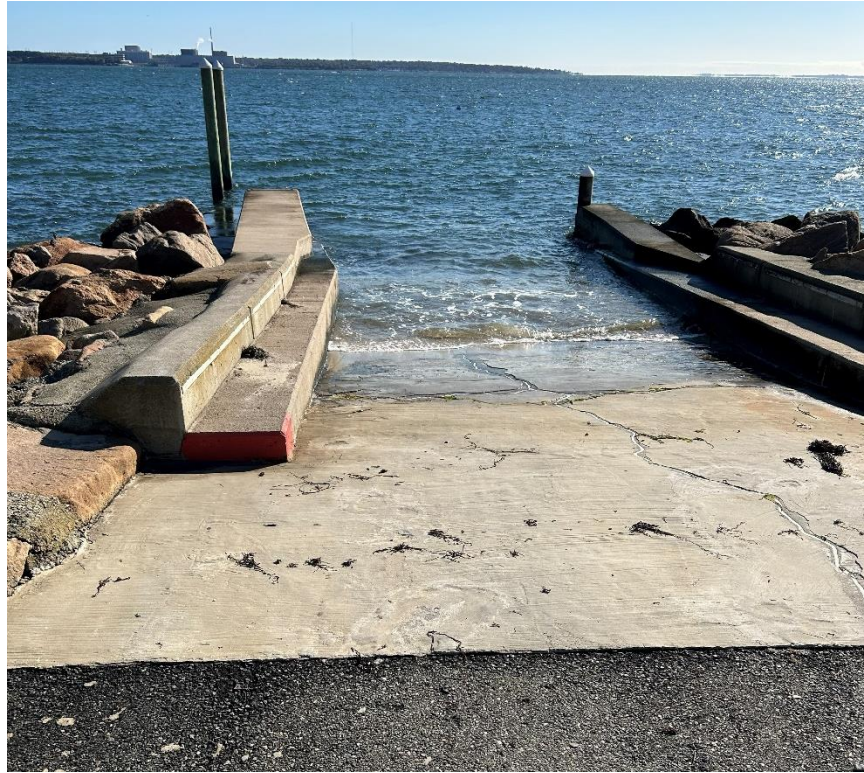
The Sea View Boat Launch off the extension of Sea View Road extending approximately 50 feet into Niantic Bay was observed to be in FAIR to POOR condition overall but remains functional for residential use. The ramp surface is steep and transitions poorly into the sand base ending abruptly and allowing large stones to accumulate at the toe and obstruct trailer access. The previous concrete overlay has failed to adhere to the substrate where crack repair material was applied, leading to delamination and surface separation along areas of the ramp.

**Photo 31: Sea View boat launch**
