# CONDITIONS ASSESSMENT OF WATERFRONT STRUCTURES

Black Point Beach Club Association

East Lyme, CT USA

Revised March 24, 2026

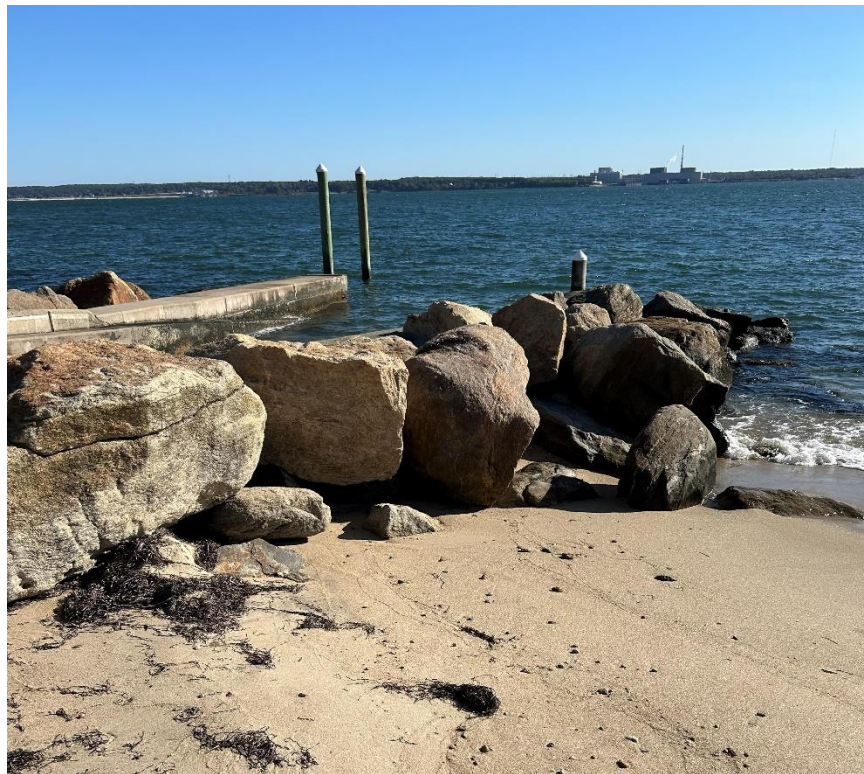
**Photo 32: Sea View boat launch South armor stone**

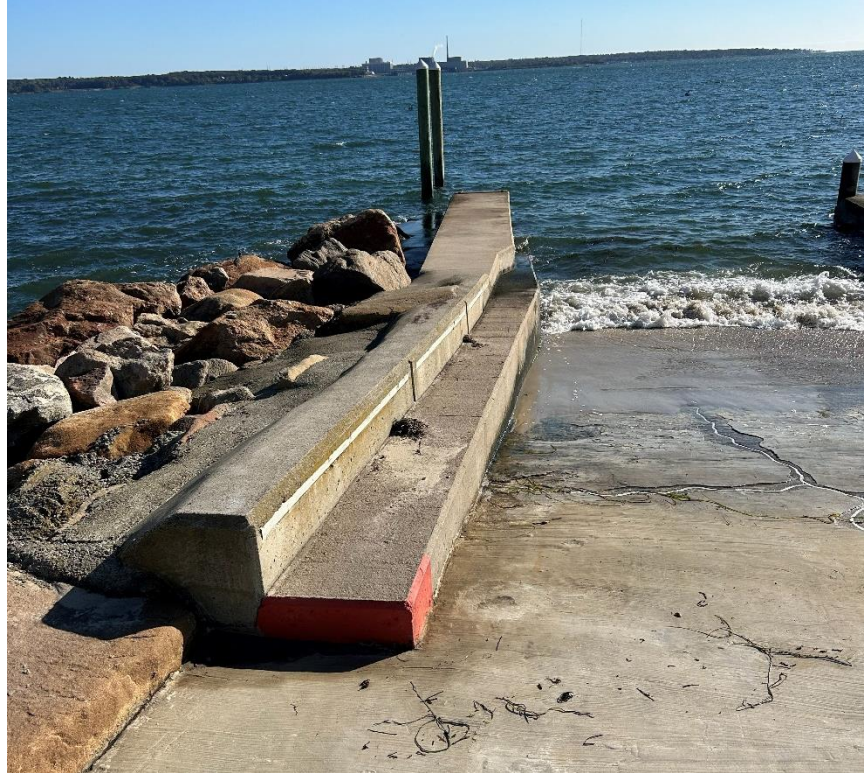
The flanking seawalls and surrounding armor stone remain in FAIR to SATISFACTORY condition, though minor stone displacement and joint separation were noted along the North edge. Recommended improvements include removal of the failed overlay, resurfacing or capping of the existing ramp, and reconstruction or extension of the slab to smoothly transition into the seabed to reduce stone buildup and restore smooth trailer access. Repairs to this structure are of minimal urgency, and residential use may continue under favorable sea conditions until work is undertaken. Extension of the ramp toe to provide smoother access and prevent stone buildup may also result in substantial cost due to the fashion of construction required for boat ramp extension including a cofferdam and upland dewatering. This extension was provided as more of a long term suggested improvement rather than an immediate or necessary repair.

**Photo 33: Sea View boat launch North wall**

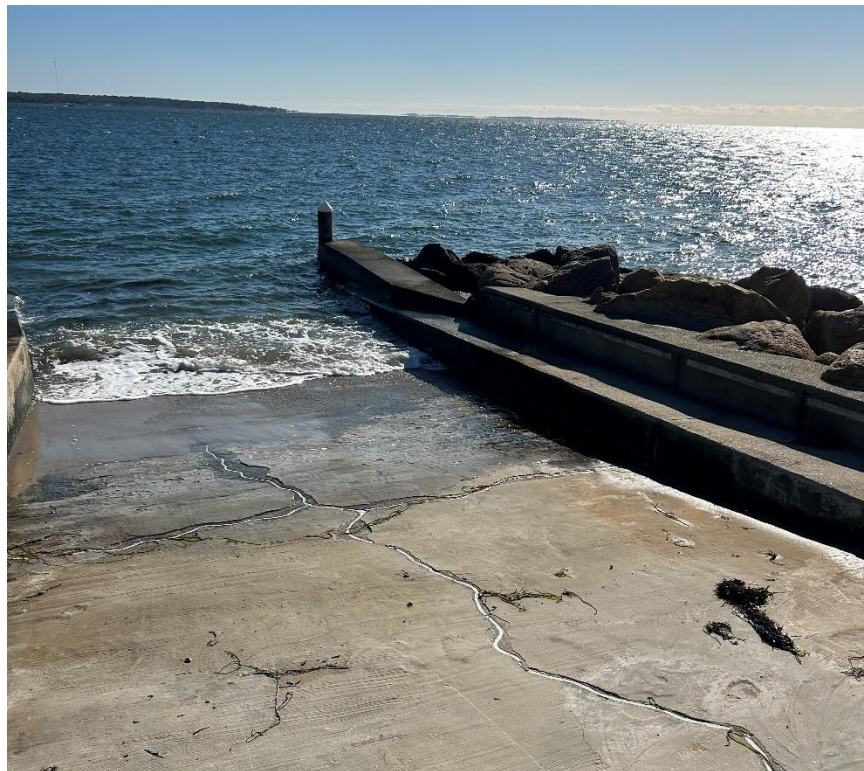
**Photo 34: Sea View boat launch South wall**

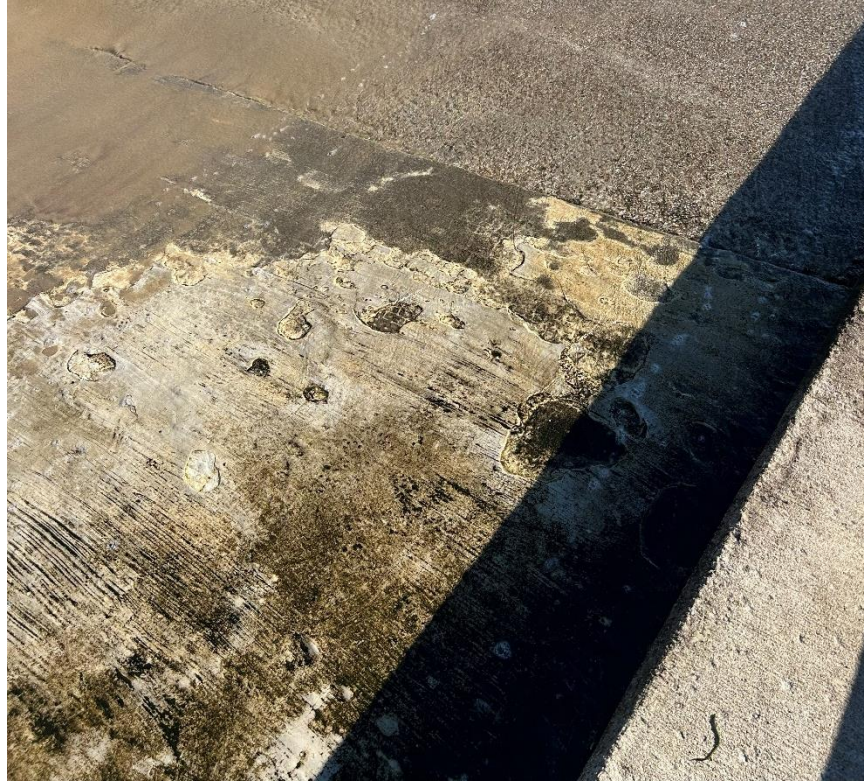
The Sea View Boat Launch off the extension of Sea View Road extending approximately 50 feet into Niantic Bay was observed to be in FAIR to POOR condition overall but remains functional for residential use. The ramp surface is steep and transitions poorly into the sand base ending abruptly and allowing large stones to accumulate at the toe and obstruct trailer access. The previous concrete overlay has failed to adhere to the substrate where crack repair material was applied, leading to delamination and surface separation along areas of the ramp.

**Photo 35: Sea View boat launch failed concrete overlay**

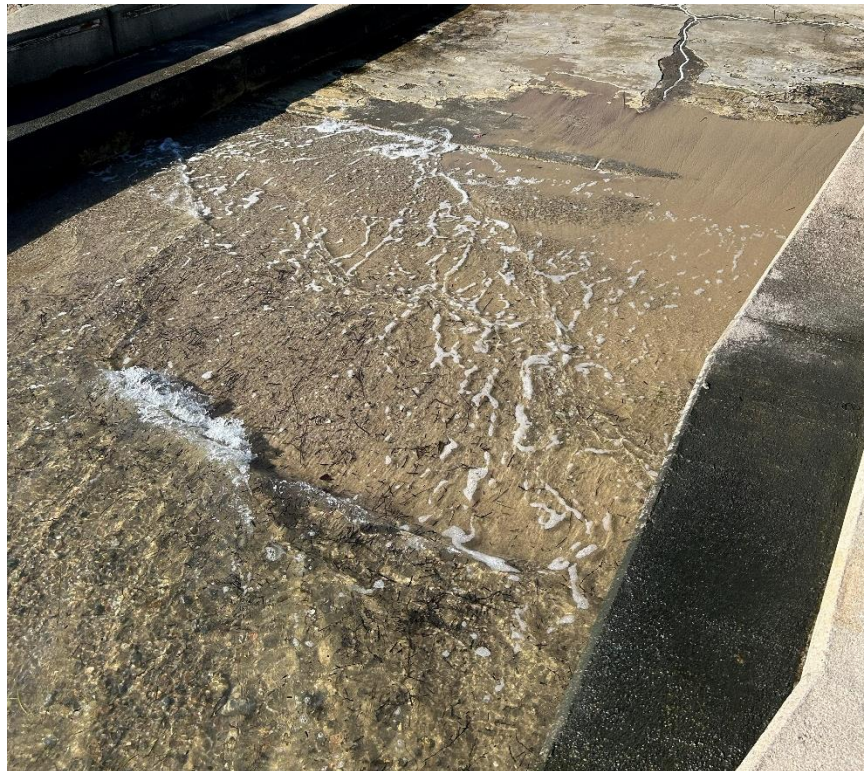
**Photo 36: Sea View boat launch sand and stones collecting at ramp toe**

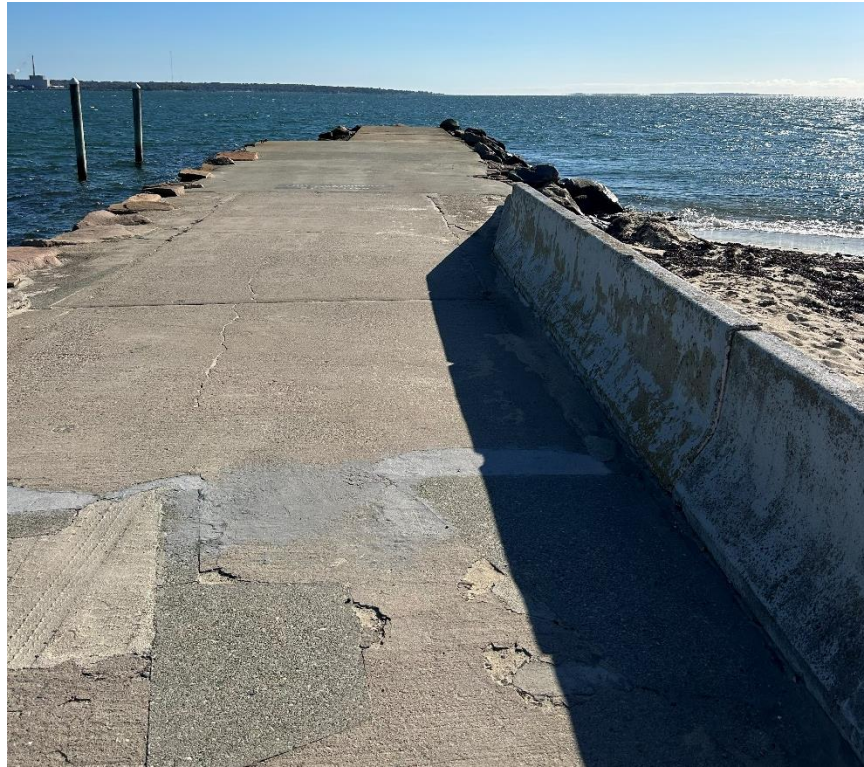
The Osprey (South Beach) pier off the extension of Osprey Road extending approximately 200 feet into Niantic Bay was observed to be in FAIR condition overall, with localized deterioration primarily along the North side. The structure consists of cast-in-place concrete slabs supported by a stacked stone wall foundation with armor stone extending along both sides. Several sections of stone along the North side have separated from the vertical wall, producing visible gaps between the slab and foundation face. While not yet structural in nature, these voids indicate gradual settlement and loss of interlock in the stone foundation.

**Photo 37: Osprey (South Beach) pier**

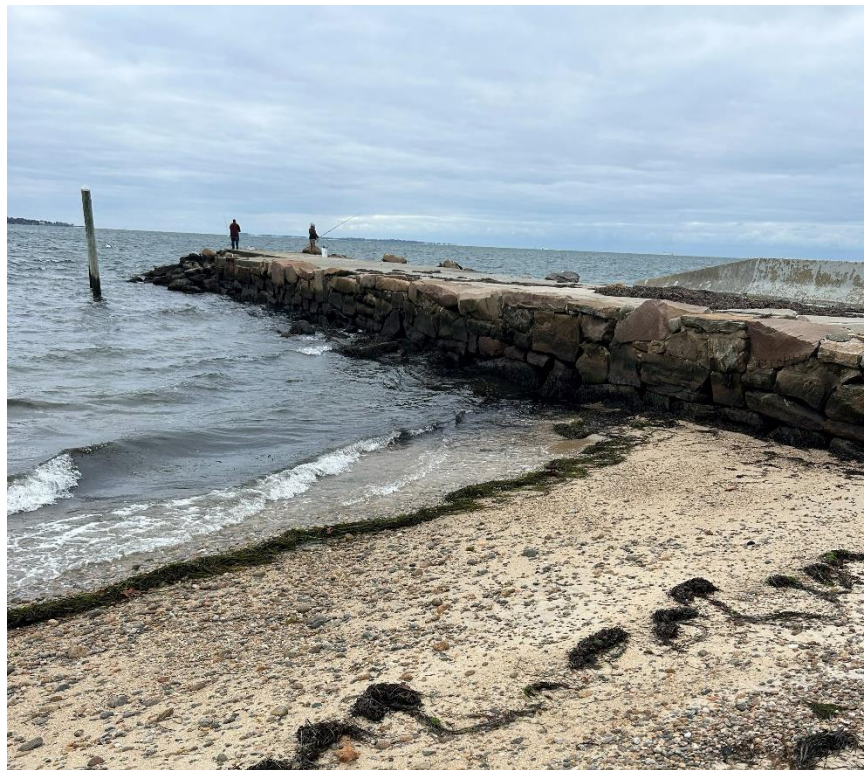
**Photo 38: Osprey (South Beach) pier North side stacked stone wall**

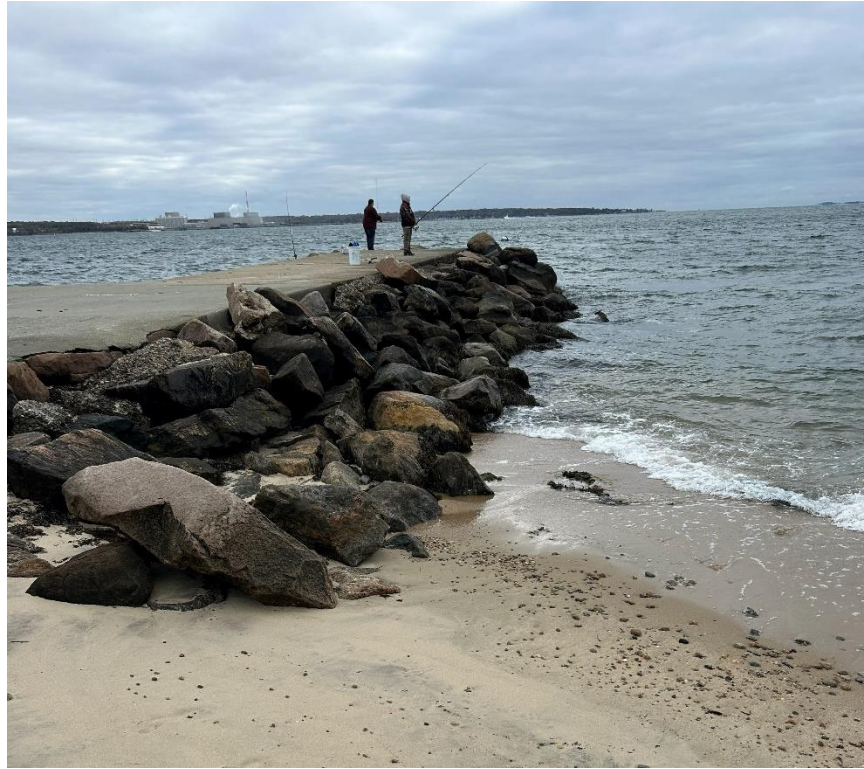
**Photo 39: Osprey (South Beach) pier South side armor stone**

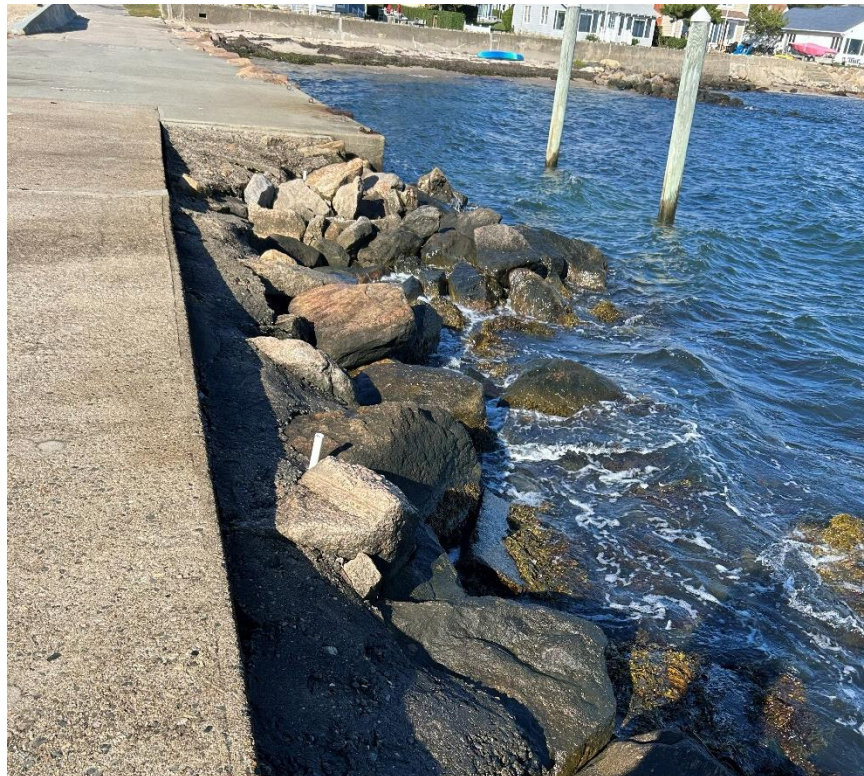
**Photo 40: Osprey (South Beach) pier displaced armor stones North side end**

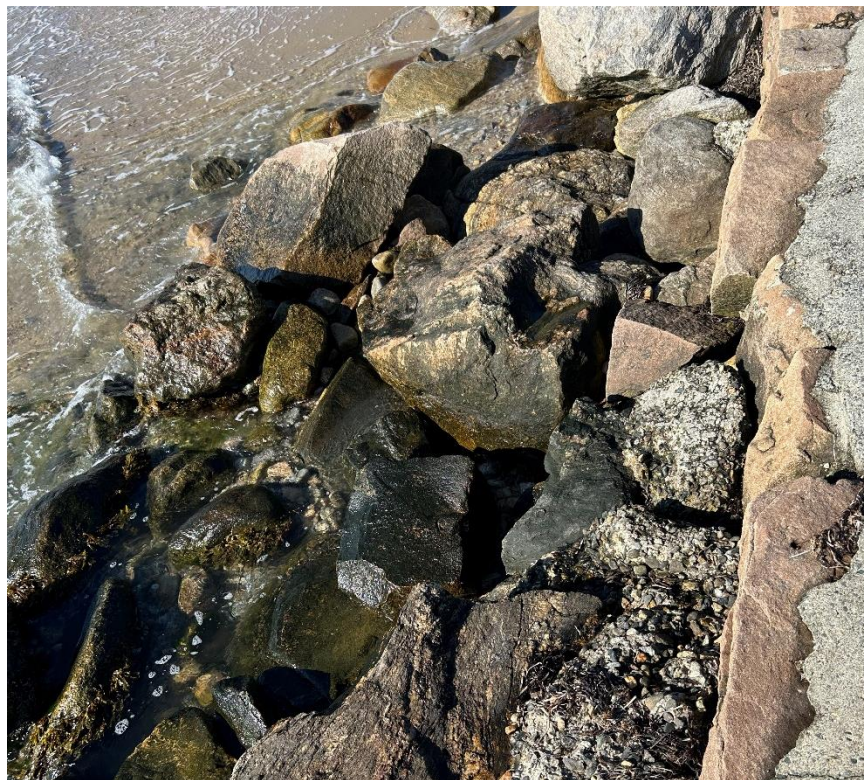
**Photo 41: Osprey (South Beach) pier displaced armor stones South side**

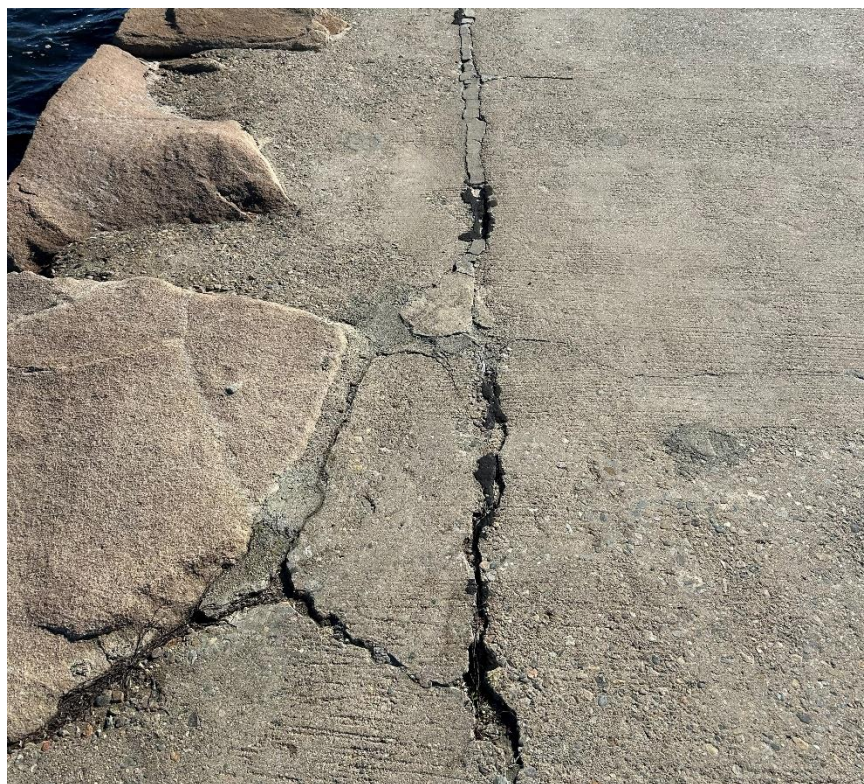
Previous stone resetting and concrete repairs remain mostly intact, though several isolated sections show stone movement and surface cracking. The pier remains safe and serviceable, but continued maintenance will be required to prevent further settlement or failure. Recommended actions include resetting displaced armor stones and replacing or repairing cracked slab sections. With routine maintenance and annual visual inspection, the structure is expected to remain serviceable for another 10–15 years before significant rehabilitation is required.

**Photo 42: Osprey (South Beach) pier concrete crack formation**

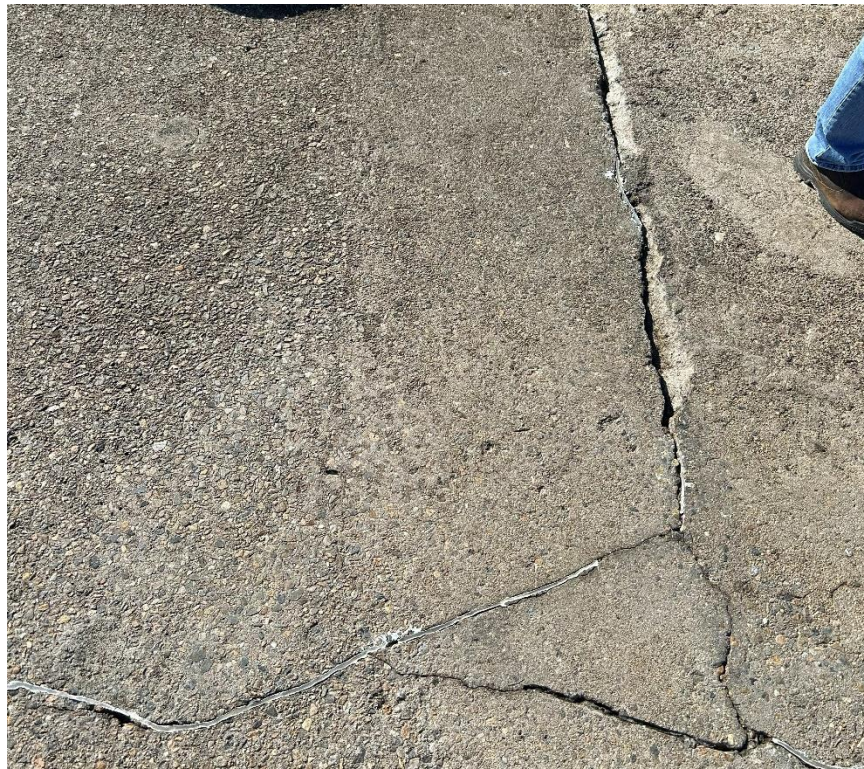
**Photo 43: Osprey (South Beach) pier additional concrete crack formation**

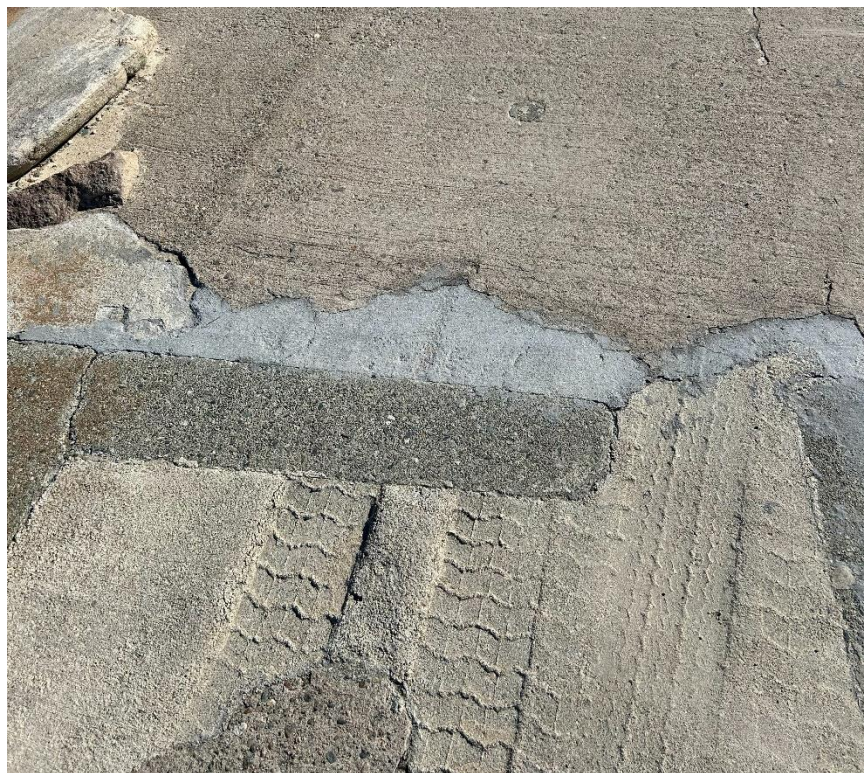
**Photo 44: Osprey (South Beach) pier previous concrete crack repair**
