Attn: Scott Bayne  
Black Point Beach Club Association  
PO Box 715  
Niantic, CT 06357

**RE: Submerged Aquatic Vegetation Survey  
Assessor Lot ID #05.11 71, Niantic, CT**

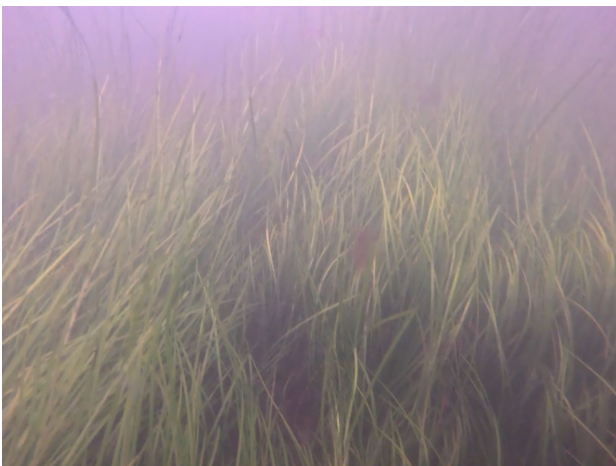
| LOCATION ID | PHOTOGRAPH | DESCRIPTION |
|---|---|---|
| 1 | | High-density mixed bed of <i>Zostera marina</i> (eelgrass) and <i>Ruppia maritima</i> (widgeon grass). |

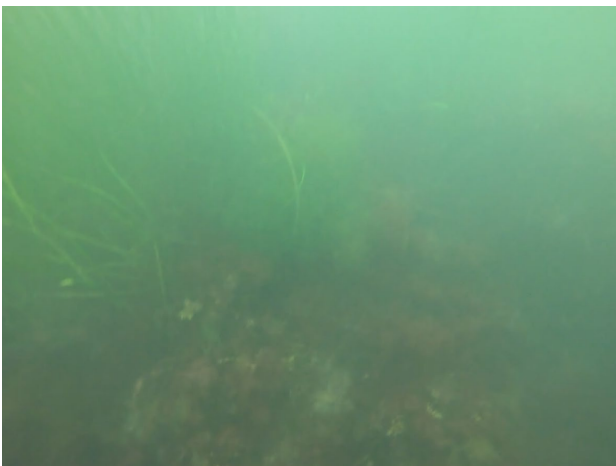
| LOCATION ID | PHOTOGRAPH | DESCRIPTION |
|---|---|---|
| 2 | | <i>Zostera marina</i> (eelgrass) rooted between large, seaweed-covered rocks. |

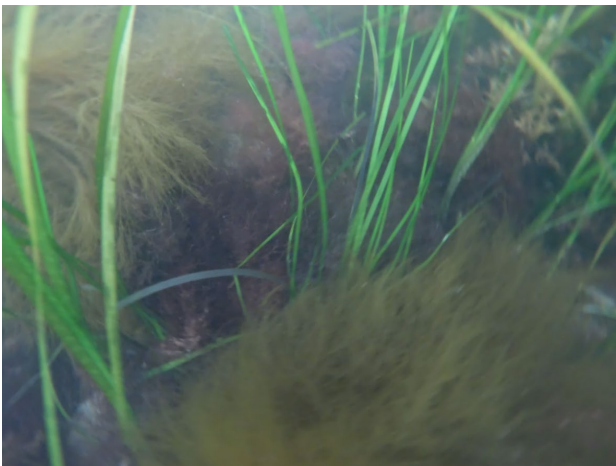
| LOCATION ID | PHOTOGRAPH | DESCRIPTION |
|---|---|---|
| 3 | | Mixed <i>Zostera marina</i> (eelgrass) and <i>Ruppia maritima</i> (widgeon grass) rooted between large, seaweed-covered rocks. |

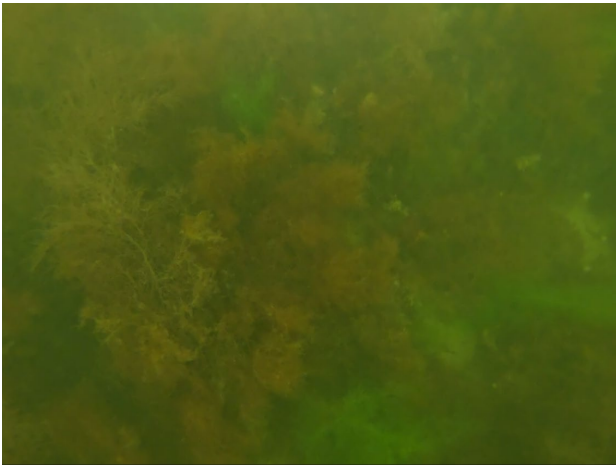
| LOCATION ID | PHOTOGRAPH | DESCRIPTION |
|---|---|---|
| 4 | | Large, seaweed-covered rocks with no visible SAV. |

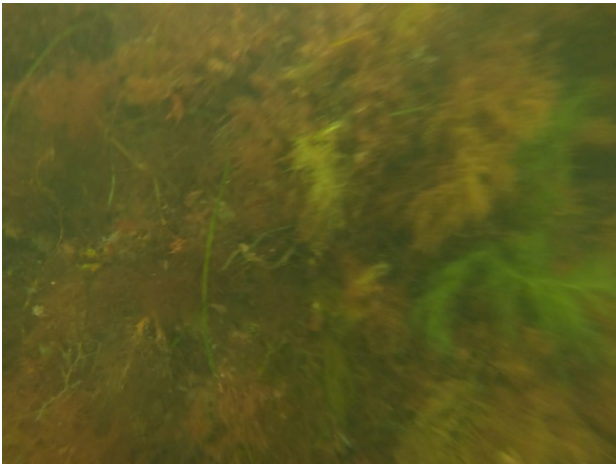
| LOCATION ID | PHOTOGRAPH | DESCRIPTION |
|---|---|---|
| 5 | | Large, seaweed-covered rocks with floating, uprooted <i>Zostera marina</i> (eelgrass) leaves. |

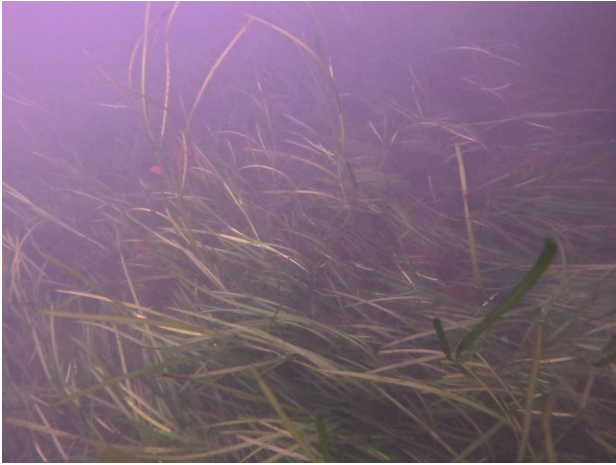
| LOCATION ID | PHOTOGRAPH | DESCRIPTION |
|---|---|---|
| 6 | | High-density mixed bed of <i>Zostera marina</i> (eelgrass) and <i>Ruppia maritima</i> (widgeon grass). |

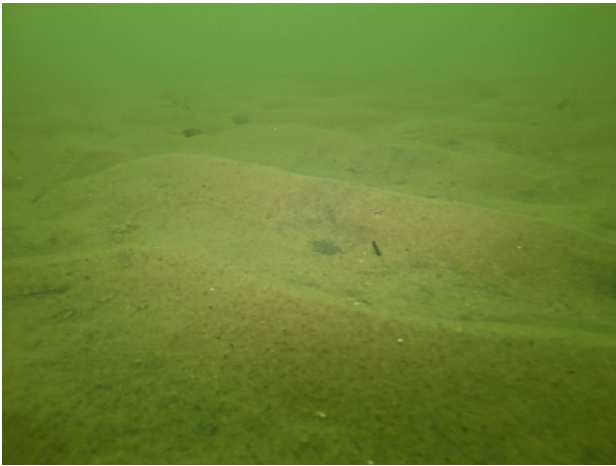
| LOCATION ID | PHOTOGRAPH | DESCRIPTION |
|---|---|---|
| 7 | | Sandy substrate with no visible SAV. |

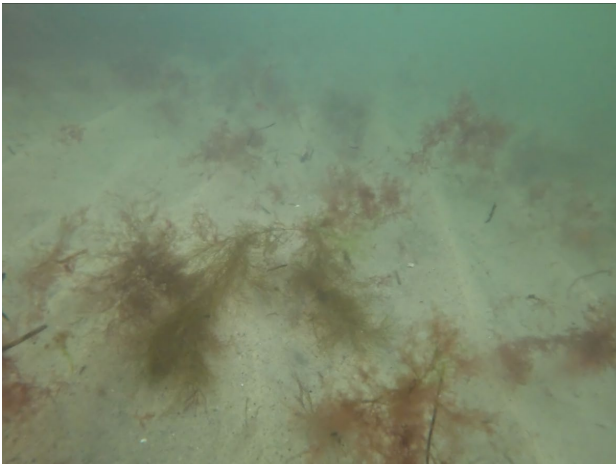
| LOCATION ID | PHOTOGRAPH | DESCRIPTION |
|---|---|---|
| 8 | | Sandy substrate covered with floating seaweed and uprooted <i>Zostera marina</i> (eelgrass) leaves. |

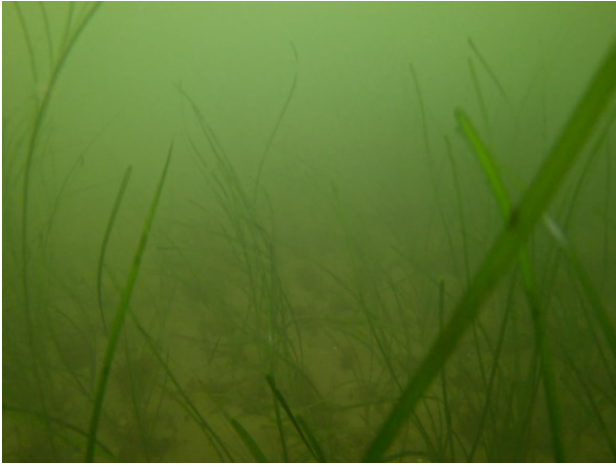
| LOCATION ID | PHOTOGRAPH | DESCRIPTION |
|---|---|---|
| 9 | | Low-density mixed bed of <i>Zostera marina</i> (eelgrass) and <i>Ruppia maritima</i> (widgeon grass). |

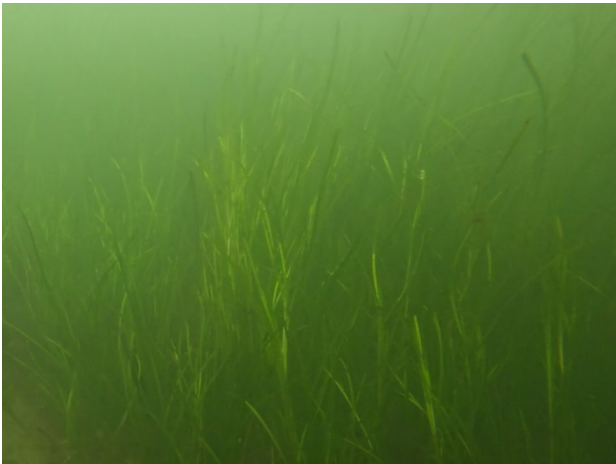
| LOCATION ID | PHOTOGRAPH | DESCRIPTION |
|---|---|---|
| 10 | | High-density mixed bed of <i>Zostera marina</i> (eelgrass) and <i>Ruppia maritima</i> (widgeon grass). |

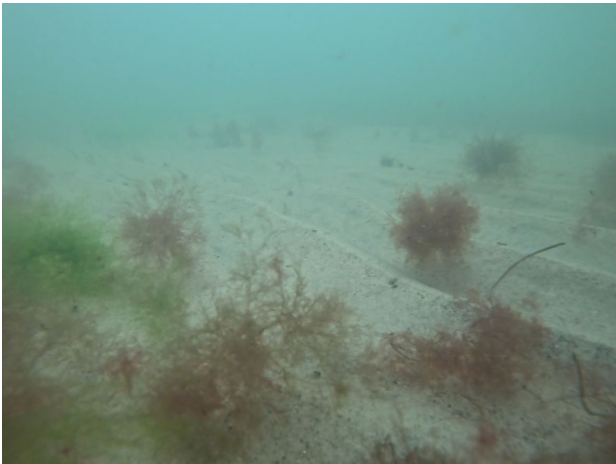
| LOCATION ID | PHOTOGRAPH | DESCRIPTION |
|---|---|---|
| 11 | | Sandy substrate covered with floating seaweed and uprooted <i>Zostera marina</i> (eelgrass) leaves. |

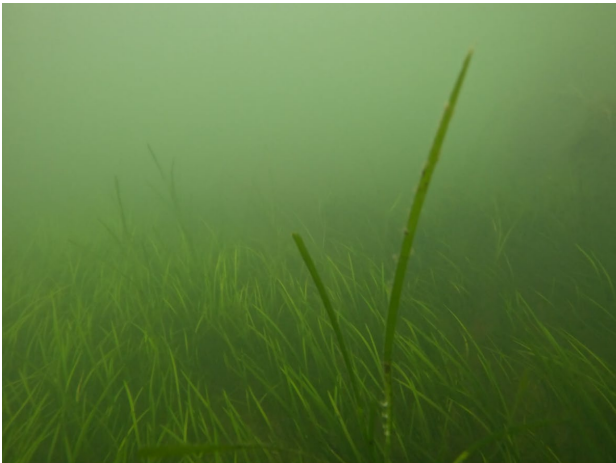
| LOCATION ID | PHOTOGRAPH | DESCRIPTION |
|---|---|---|
| 12 | | High-density mixed bed of <i>Zostera marina</i> (eelgrass) and <i>Ruppia maritima</i> (widgeon grass). |

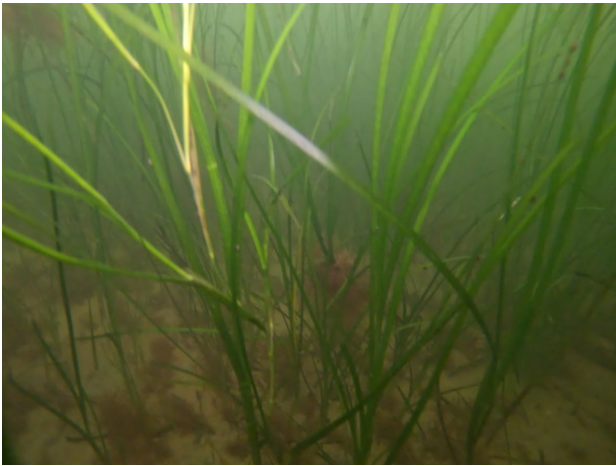
| LOCATION ID | PHOTOGRAPH | DESCRIPTION |
|---|---|---|
| 13 | | Low-density mixed bed of <i>Zostera marina</i> (eelgrass) and <i>Ruppia maritima</i> (widgeon grass). |

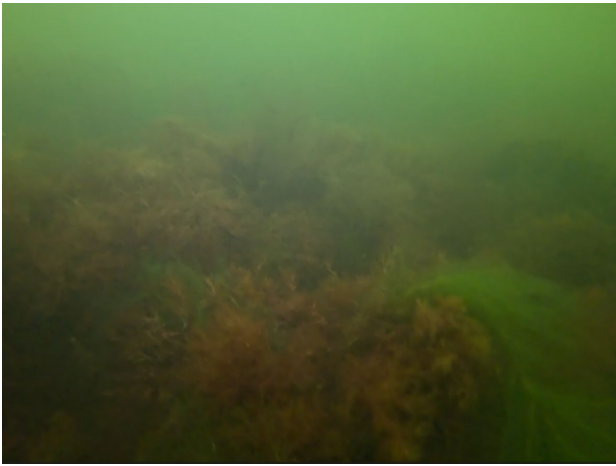
| LOCATION ID | PHOTOGRAPH | DESCRIPTION |
|---|---|---|
| 14 | | Large, seaweed-covered rocks with no visible SAV. |

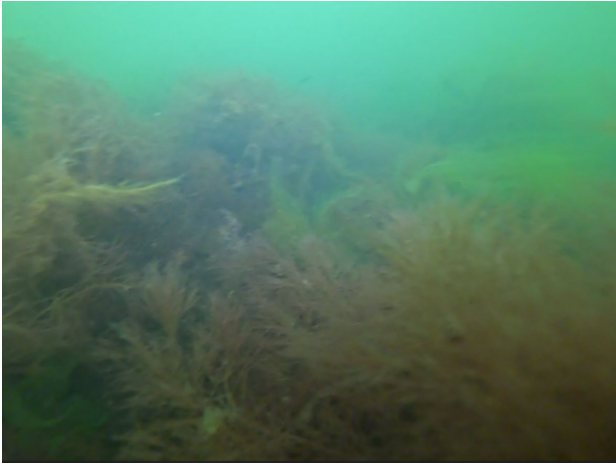
| LOCATION ID | PHOTOGRAPH | DESCRIPTION |
|---|---|---|
| 15 | | Large, seaweed-covered rocks with no visible SAV. |

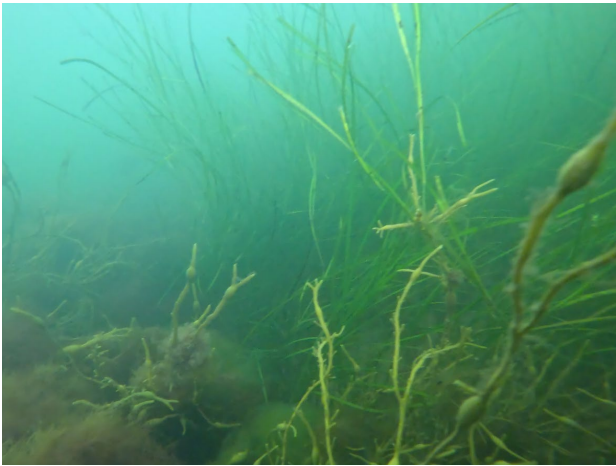
| LOCATION ID | PHOTOGRAPH | DESCRIPTION |
|---|---|---|
| 16 | | Mixed <i>Zostera marina</i> (eelgrass) and <i>Ruppia maritima</i> (widgeon grass) rooted between large, seaweed-covered rocks. |

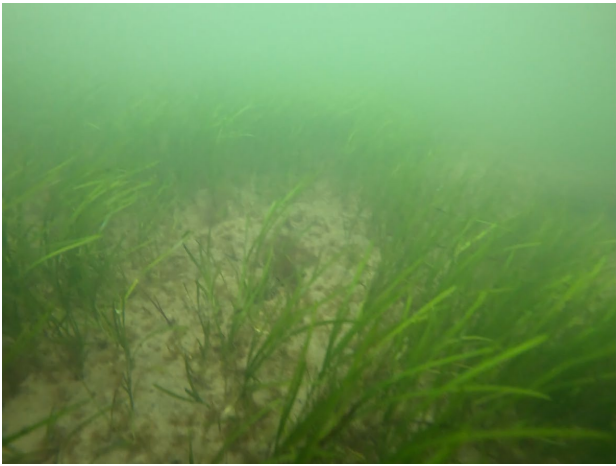
| LOCATION ID | PHOTOGRAPH | DESCRIPTION |
|---|---|---|
| 17 | | Moderate-density mixed bed of <i>Zostera marina</i> (eelgrass) and <i>Ruppia maritima</i> (widgeon grass). |

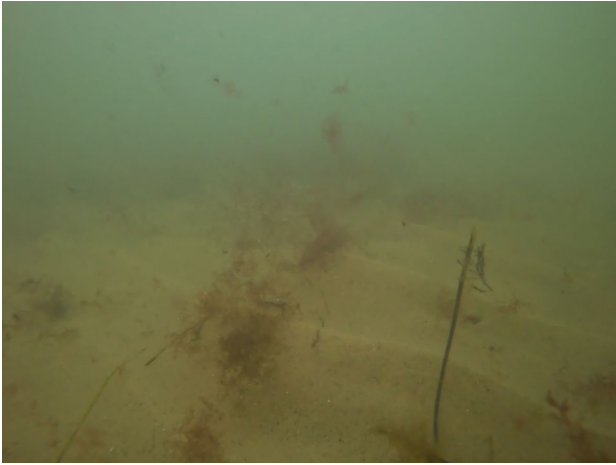
| LOCATION ID | PHOTOGRAPH | DESCRIPTION |
|---|---|---|
| 18 | | Sandy substrate covered with floating seaweed and uprooted <i>Zostera marina</i> (eelgrass) leaves. |

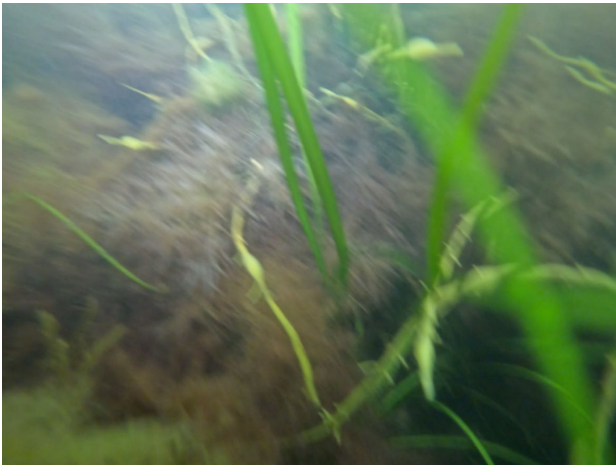
| LOCATION ID | PHOTOGRAPH | DESCRIPTION |
|---|---|---|
| 19 | | <i>Zostera marina</i> (eelgrass) rooted between large, seaweed-covered rocks. |

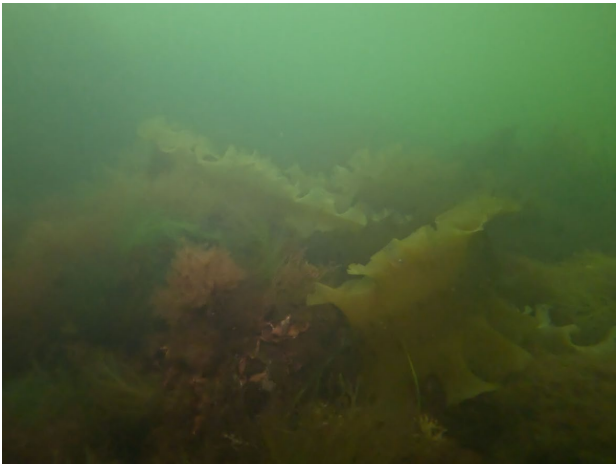
| LOCATION ID | PHOTOGRAPH | DESCRIPTION |
|---|---|---|
| 20 | | Large, seaweed-covered rocks with no visible SAV. |

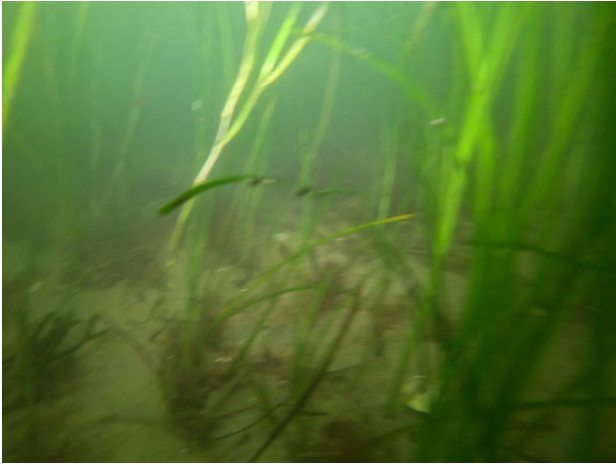
| LOCATION ID | PHOTOGRAPH | DESCRIPTION |
|---|---|---|
| 21 | | Low-density mixed bed of <i>Zostera marina</i> (eelgrass) and <i>Ruppia maritima</i> (widgeon grass). |

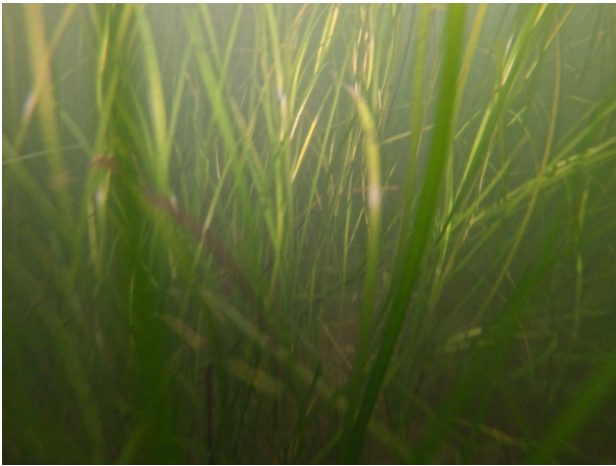
| LOCATION ID | PHOTOGRAPH | DESCRIPTION |
|---|---|---|
| 22 | | High-density mixed bed of <i>Zostera marina</i> (eelgrass) and <i>Ruppia maritima</i> (widgeon grass). |

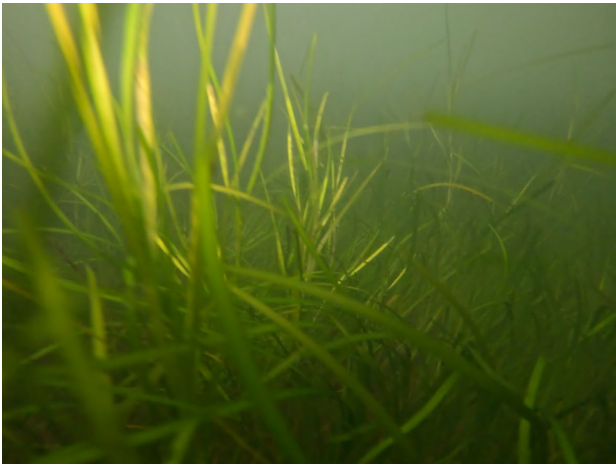
| LOCATION ID | PHOTOGRAPH | DESCRIPTION |
|---|---|---|
| 23 | | High-density mixed bed of <i>Zostera marina</i> (eelgrass) and <i>Ruppia maritima</i> (widgeon grass). |

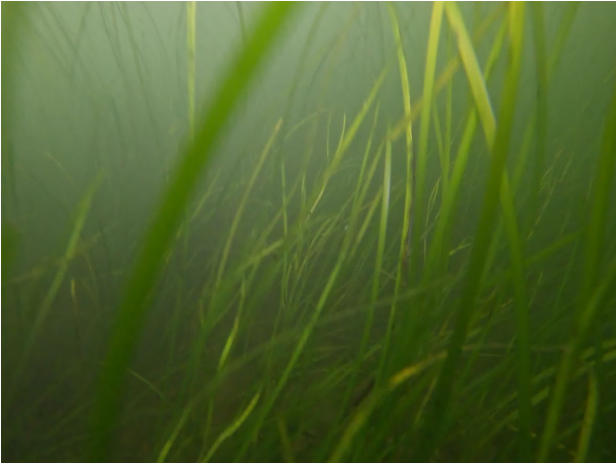
| LOCATION ID | PHOTOGRAPH | DESCRIPTION |
|---|---|---|
| 24 | | Moderate-density mixed bed of <i>Zostera marina</i> (eelgrass) and <i>Ruppia maritima</i> (widgeon grass). |

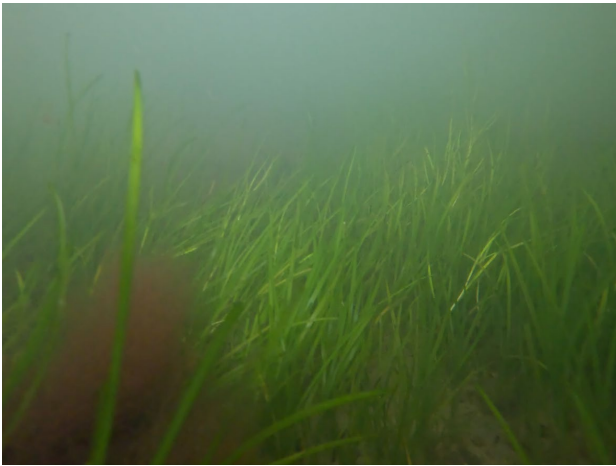
| LOCATION ID | PHOTOGRAPH | DESCRIPTION |
|---|---|---|
| 25 | | High-density mixed bed of <i>Zostera marina</i> (eelgrass) and <i>Ruppia maritima</i> (widgeon grass). |

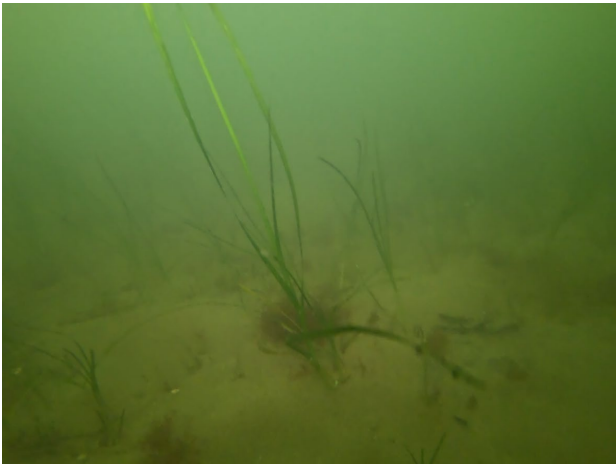
| LOCATION ID | PHOTOGRAPH | DESCRIPTION |
|---|---|---|
| 26 | | Sparse bed of <i>Zostera marina</i> (eelgrass). |

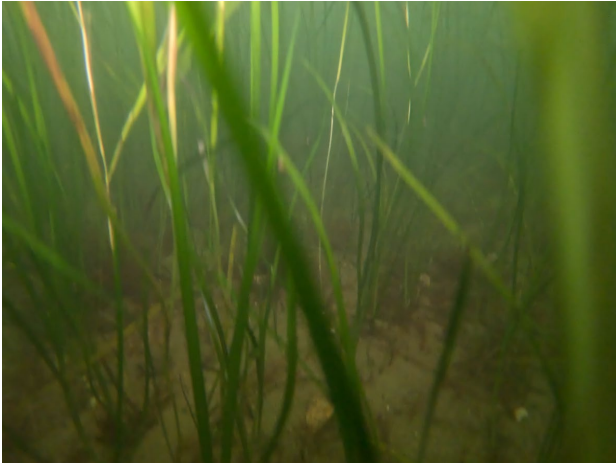
| LOCATION ID | PHOTOGRAPH | DESCRIPTION |
|---|---|---|
| 27 | | Low-density mixed bed of <i>Zostera marina</i> (eelgrass) and <i>Ruppia maritima</i> (widgeon grass). |

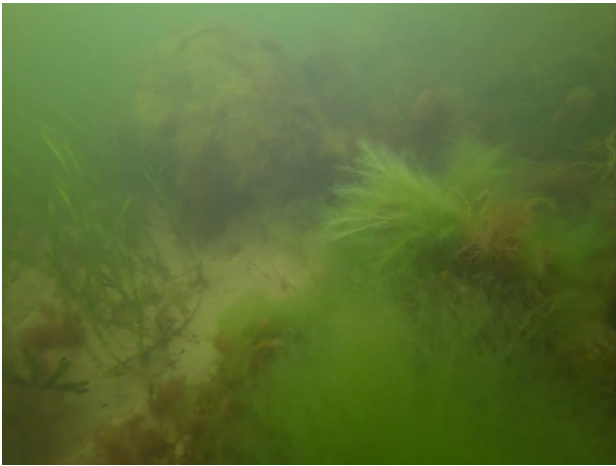
| LOCATION ID | PHOTOGRAPH | DESCRIPTION |
|---|---|---|
| 28 | | Mixed <i>Zostera marina</i> (eelgrass) and <i>Ruppia maritima</i> (widgeon grass) rooted between large, seaweed-covered rocks. |

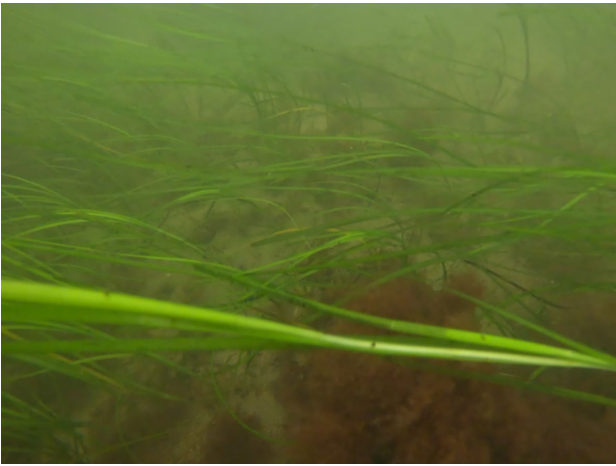
| LOCATION ID | PHOTOGRAPH | DESCRIPTION |
|---|---|---|
| 29 | | Low-density mixed bed of <i>Zostera marina</i> (eelgrass) and <i>Ruppia maritima</i> (widgeon grass). |

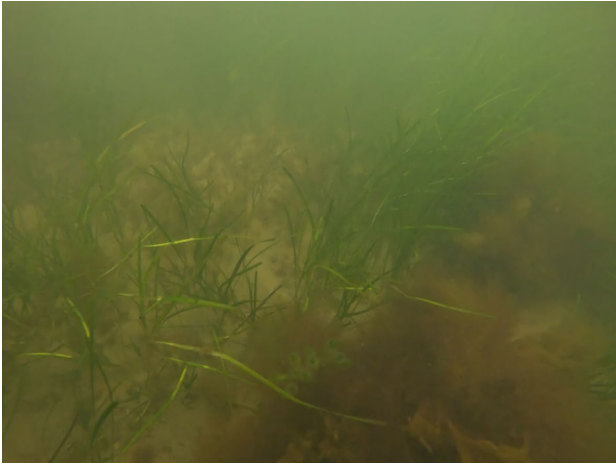
| LOCATION ID | PHOTOGRAPH | DESCRIPTION |
|---|---|---|
| 30 | | Low-density mixed bed of <i>Zostera marina</i> (eelgrass) and <i>Ruppia maritima</i> (widgeon grass). |

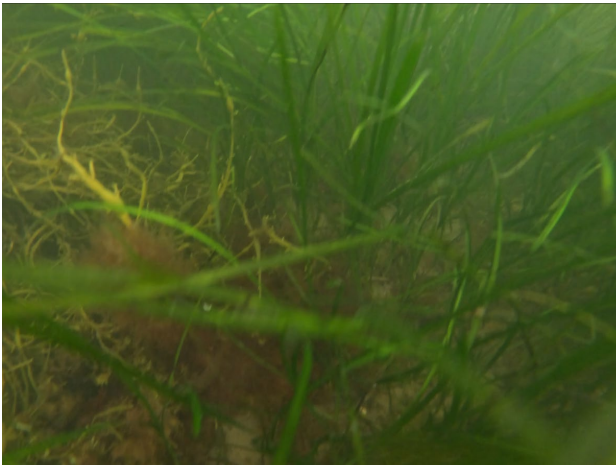
| LOCATION ID | PHOTOGRAPH | DESCRIPTION |
|---|---|---|
| 31 | | Mixed <i>Zostera marina</i> (eelgrass) and <i>Ruppia maritima</i> (widgeon grass) rooted between large, seaweed-covered rocks. |

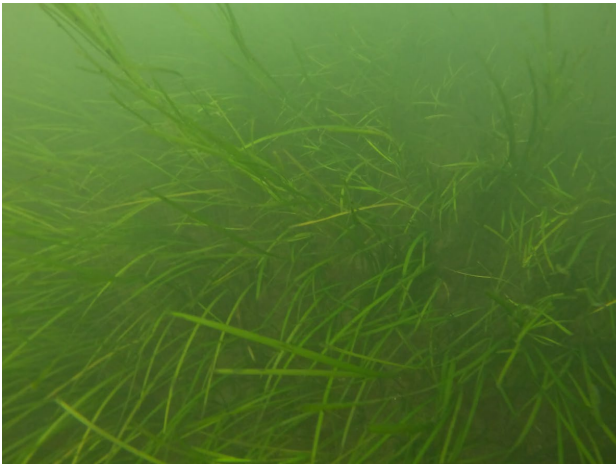
| LOCATION ID | PHOTOGRAPH | DESCRIPTION |
|---|---|---|
| 32 | | High-density mixed bed of <i>Zostera marina</i> (eelgrass) and <i>Ruppia maritima</i> (widgeon grass). |

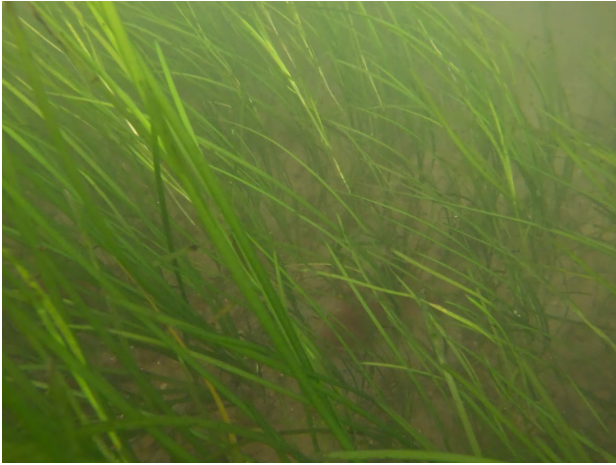
| LOCATION ID | PHOTOGRAPH | DESCRIPTION |
|---|---|---|
| 33 | | Moderate-density mixed bed of <i>Zostera marina</i> (eelgrass) and <i>Ruppia maritima</i> (widgeon grass). |

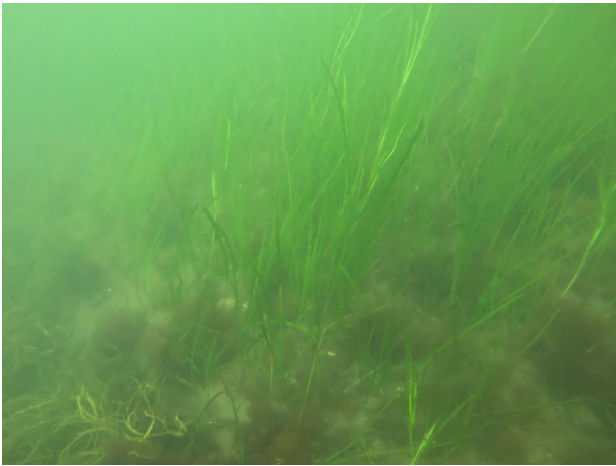
| LOCATION ID | PHOTOGRAPH | DESCRIPTION |
|---|---|---|
| 34 | | Mixed <i>Zostera marina</i> (eelgrass) and <i>Ruppia maritima</i> (widgeon grass) rooted between small, seaweed covered rocks. |

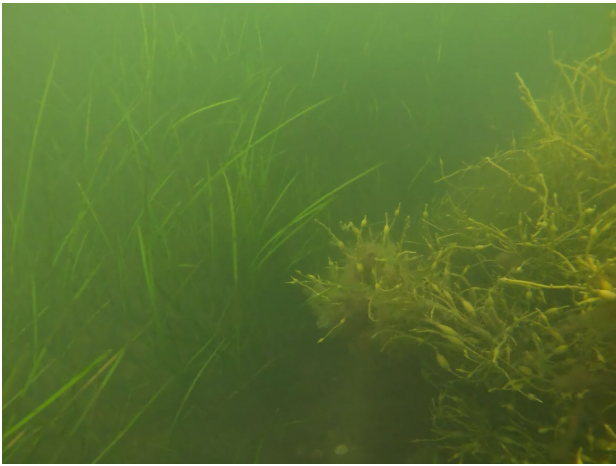
| LOCATION ID | PHOTOGRAPH | DESCRIPTION |
|---|---|---|
| 35 | | Mixed <i>Zostera marina</i> (eelgrass) and <i>Ruppia maritima</i> (widgeon grass) rooted between large, seaweed covered rocks. |

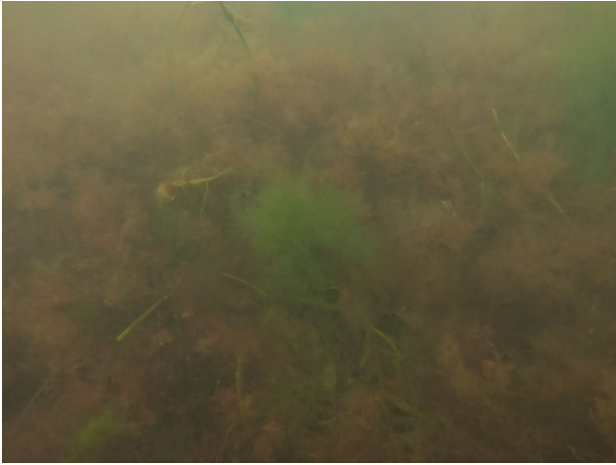
| LOCATION ID | PHOTOGRAPH | DESCRIPTION |
|---|---|---|
| 36 | | Large, seaweed-covered rocks and floating, uprooted <i>Zostera marina</i> (eelgrass) leaves. |

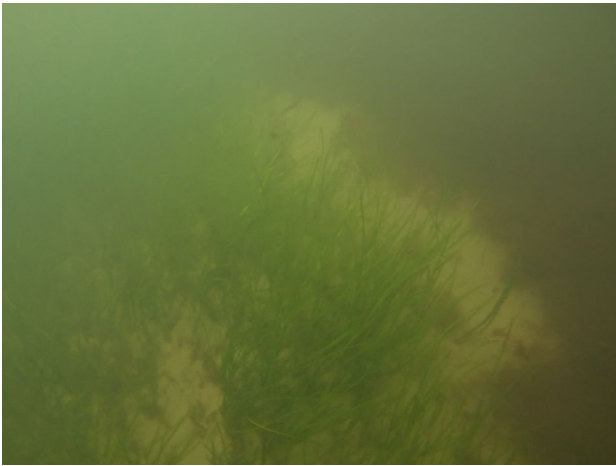
| LOCATION ID | PHOTOGRAPH | DESCRIPTION |
|---|---|---|
| 37 | | Edge of moderate-density mixed bed of <i>Zostera marina</i> (eelgrass) and <i>Ruppia maritima</i> (widgeon grass). |

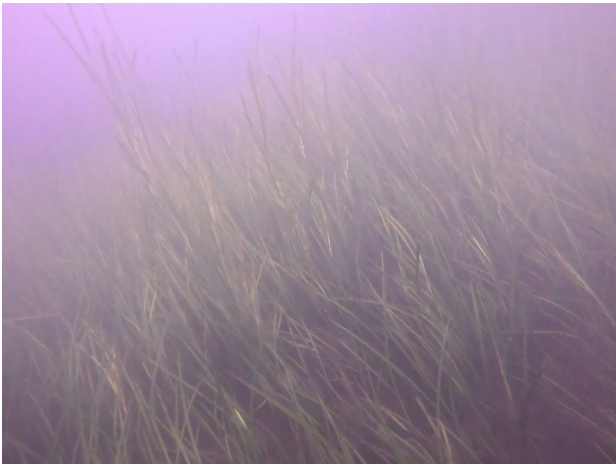
| LOCATION ID | PHOTOGRAPH | DESCRIPTION |
|---|---|---|
| 38 | | High-density mixed bed of <i>Zostera marina</i> (eelgrass) and <i>Ruppia maritima</i> (widgeon grass). |

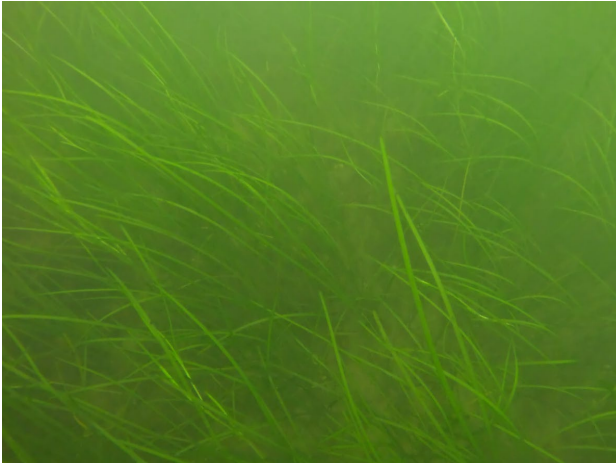
| LOCATION ID | PHOTOGRAPH | DESCRIPTION |
|---|---|---|
| 39 | | High-density mixed bed of <i>Zostera marina</i> (eelgrass) and <i>Ruppia maritima</i> (widgeon grass). |

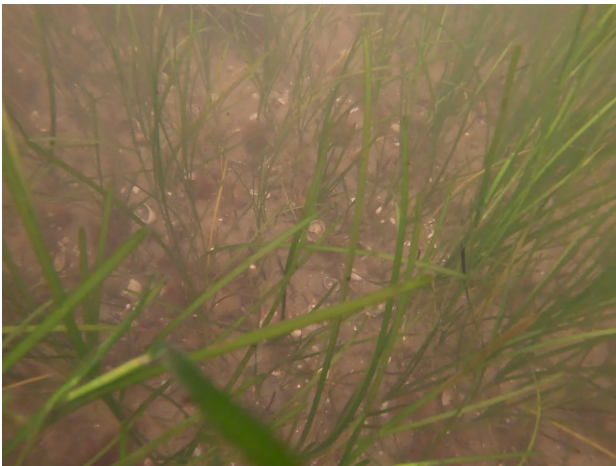
| LOCATION ID | PHOTOGRAPH | DESCRIPTION |
|---|---|---|
| 40 | | Low-density bed of <i>Zostera marina</i> (eelgrass). |

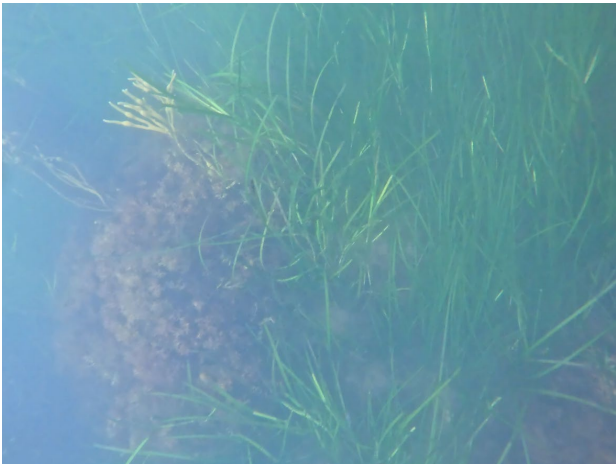
| LOCATION ID | PHOTOGRAPH | DESCRIPTION |
|---|---|---|
| 41 | | Mixed <i>Zostera marina</i> (eelgrass) and <i>Ruppia maritima</i> (widgeon grass) rooted between large, seaweed-covered rocks. |

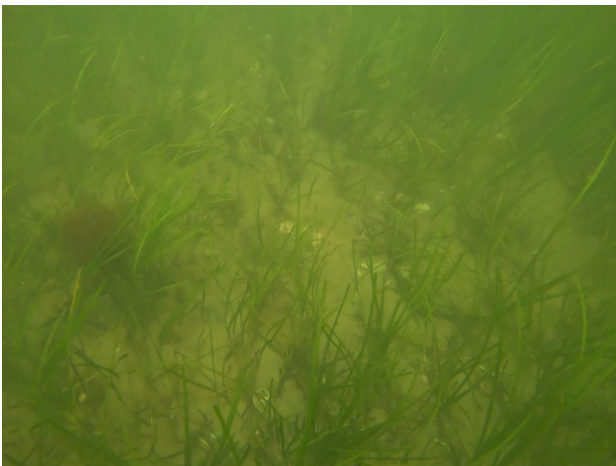
| LOCATION ID | PHOTOGRAPH | DESCRIPTION |
|---|---|---|
| 42 | | Low-density mixed bed of <i>Zostera marina</i> (eelgrass) and <i>Ruppia maritima</i> (widgeon grass). |

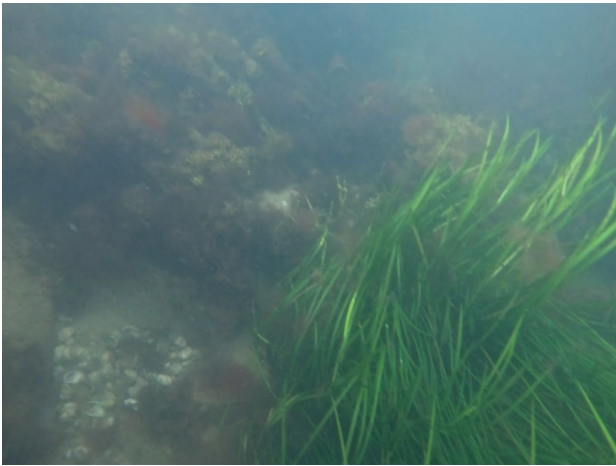
| LOCATION ID | PHOTOGRAPH | DESCRIPTION |
|---|---|---|
| 43 | | <i>Zostera marina</i> (eelgrass) growing between large rocks, which are covered in seaweed. |

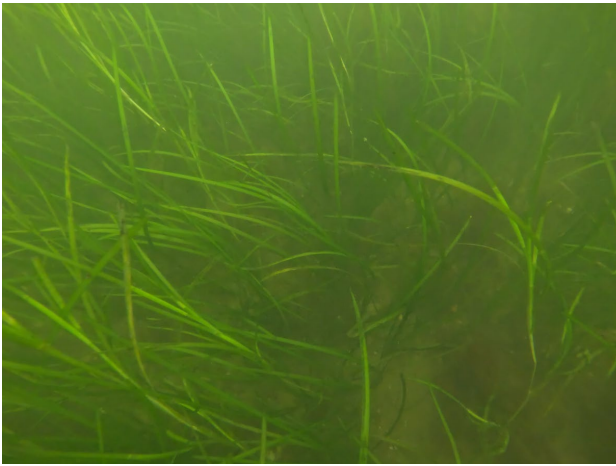
| LOCATION ID | PHOTOGRAPH | DESCRIPTION |
|---|---|---|
| 44 | | High-density mixed bed of <i>Zostera marina</i> (eelgrass) and <i>Ruppia maritima</i> (widgeon grass). |

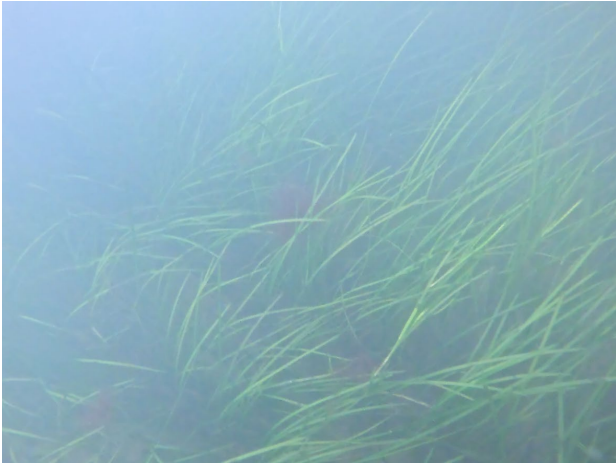
| LOCATION ID | PHOTOGRAPH | DESCRIPTION |
|---|---|---|
| 45 | | High-density mixed bed of <i>Zostera marina</i> (eelgrass) and <i>Ruppia maritima</i> (widgeon grass). |

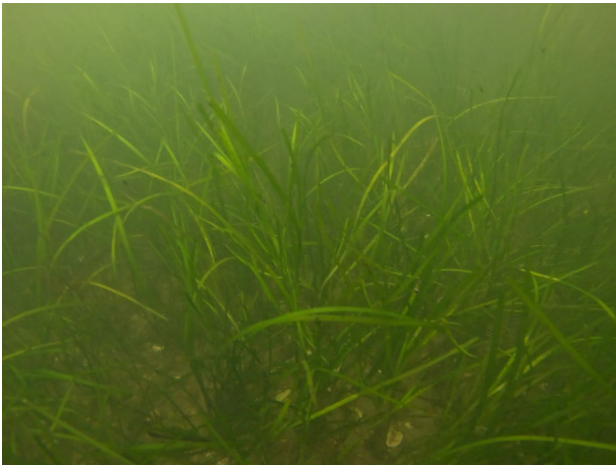
| LOCATION ID | PHOTOGRAPH | DESCRIPTION |
|---|---|---|
| 46 | | High-density mixed bed of <i>Zostera marina</i> (eelgrass) and <i>Ruppia maritima</i> (widgeon grass). |

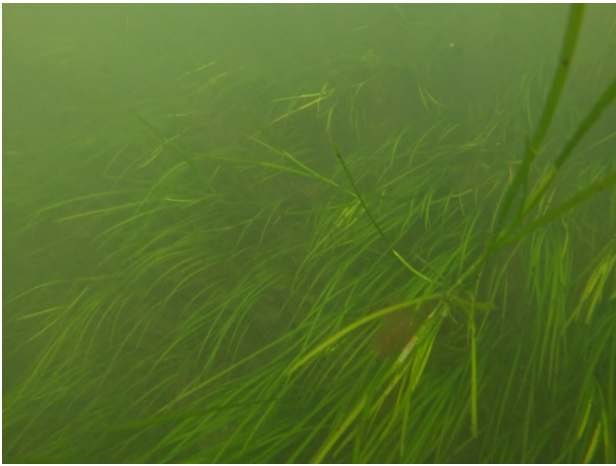
| LOCATION ID | PHOTOGRAPH | DESCRIPTION |
|---|---|---|
| 47 | | High-density mixed bed of <i>Zostera marina</i> (eelgrass) and <i>Ruppia maritima</i> (widgeon grass). |

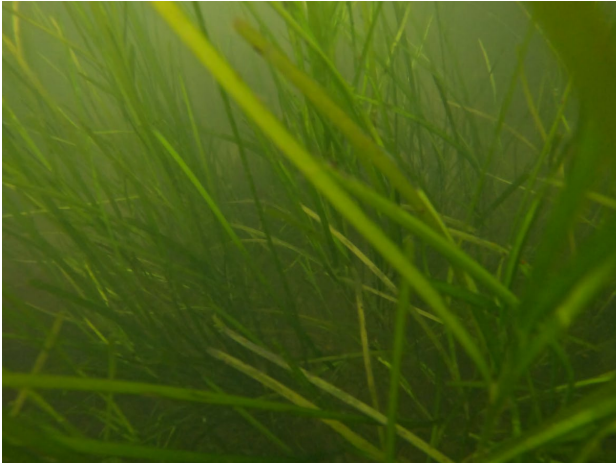
| LOCATION ID | PHOTOGRAPH | DESCRIPTION |
|---|---|---|
| 48 | | High-density mixed bed of <i>Zostera marina</i> (eelgrass) and <i>Ruppia maritima</i> (widgeon grass). |

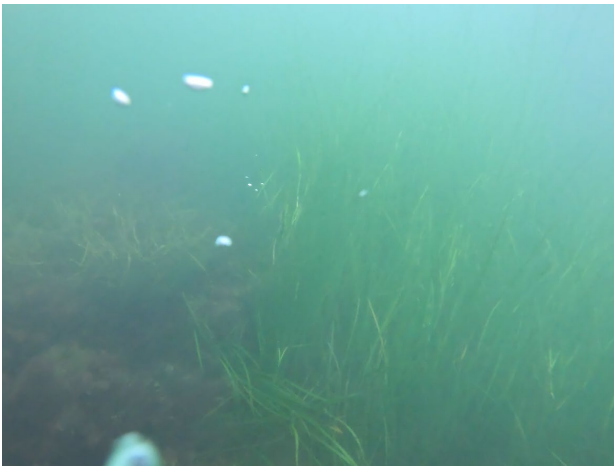
| LOCATION ID | PHOTOGRAPH | DESCRIPTION |
|---|---|---|
| 49 | | High-density mixed bed of <i>Zostera marina</i> (eelgrass) and <i>Ruppia maritima</i> (widgeon grass) growing around large, seaweed-covered rocks. |

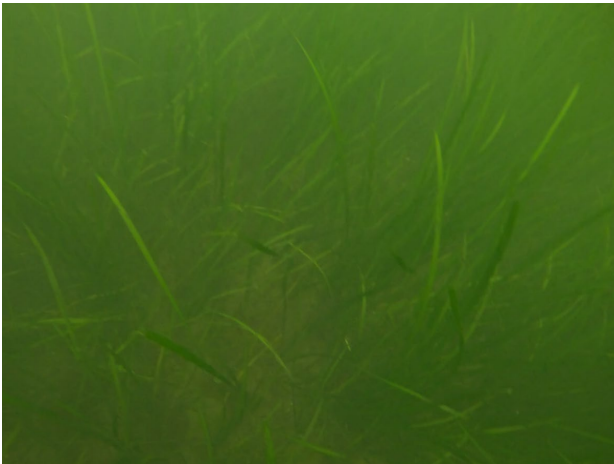
| LOCATION ID | PHOTOGRAPH | DESCRIPTION |
|---|---|---|
| 50 | | High-density mixed bed of <i>Zostera marina</i> (eelgrass) and <i>Ruppia maritima</i> (widgeon grass). |

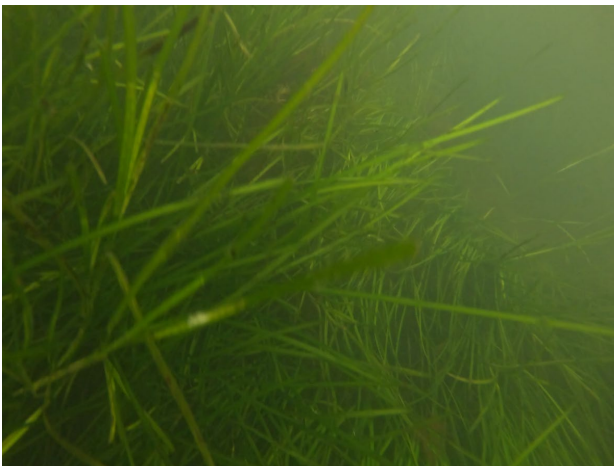
| LOCATION ID | PHOTOGRAPH | DESCRIPTION |
|---|---|---|
| 51 | | High-density mixed bed of <i>Zostera marina</i> (eelgrass) and <i>Ruppia maritima</i> (widgeon grass). |

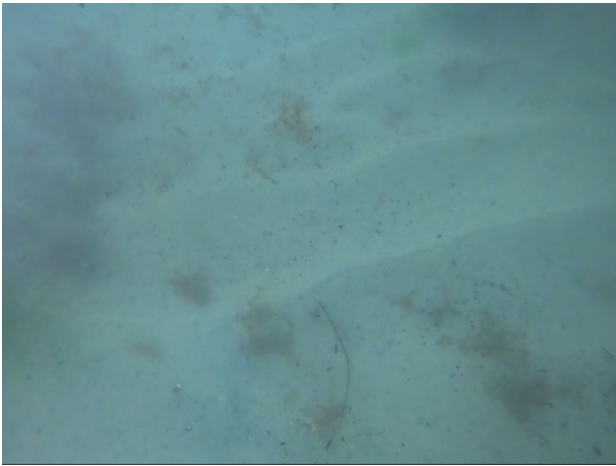
| LOCATION ID | PHOTOGRAPH | DESCRIPTION |
|---|---|---|
| 52 | | Sandy substrate covered with floating seaweed and uprooted <i>Zostera marina</i> (eelgrass) leaves. |

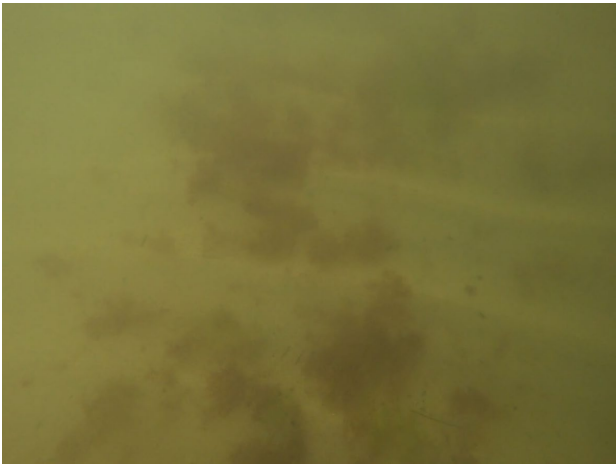
| LOCATION ID | PHOTOGRAPH | DESCRIPTION |
|---|---|---|
| 53 | | Sandy substrate covered with floating seaweed. No visible SAV. |

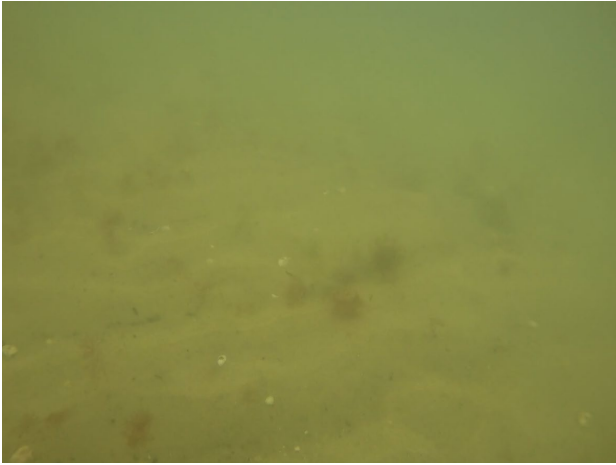
| LOCATION ID | PHOTOGRAPH | DESCRIPTION |
|---|---|---|
| 54 | | Sandy substrate covered with floating seaweed. No visible SAV. |

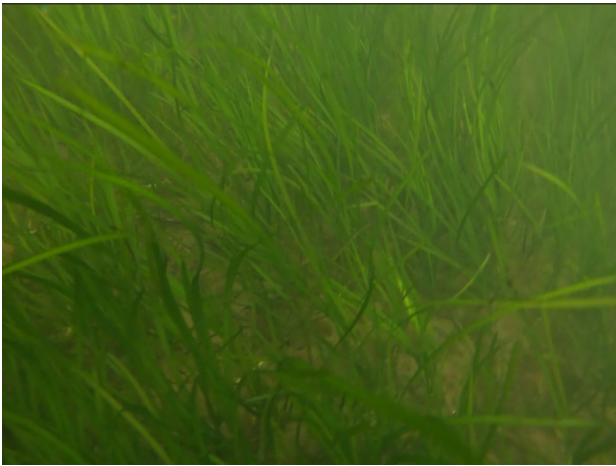
| LOCATION ID | PHOTOGRAPH | DESCRIPTION |
|---|---|---|
| 55 | | High-density mixed bed of <i>Zostera marina</i> (eelgrass) and <i>Ruppia maritima</i> (widgeon grass). |

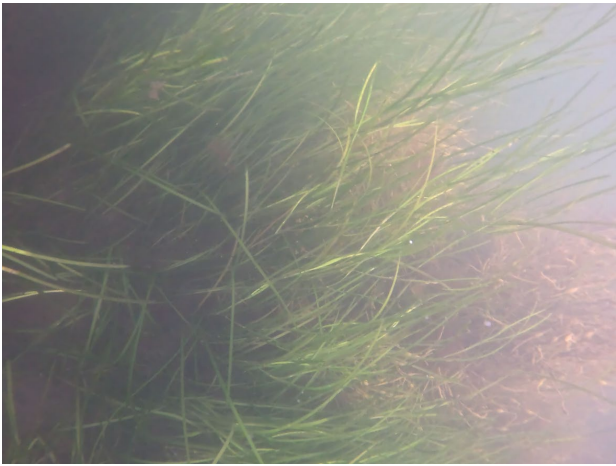
| LOCATION ID | PHOTOGRAPH | DESCRIPTION |
|---|---|---|
| 56 | | High-density mixed bed of <i>Zostera marina</i> (eelgrass) and <i>Ruppia maritima</i> (widgeon grass). |

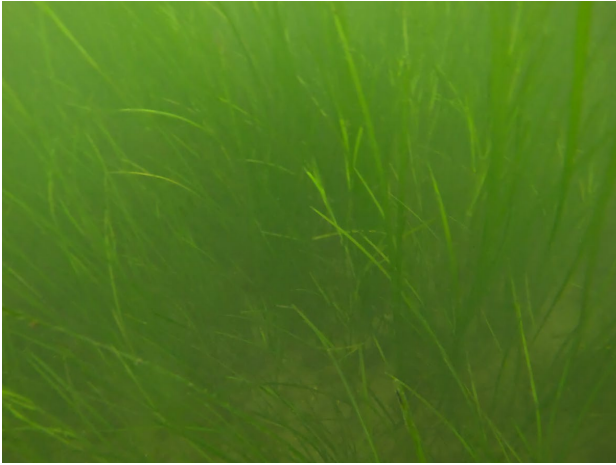
| LOCATION ID | PHOTOGRAPH | DESCRIPTION |
|---|---|---|
| 57 | | High-density mixed bed of <i>Zostera marina</i> (eelgrass) and <i>Ruppia maritima</i> (widgeon grass). |

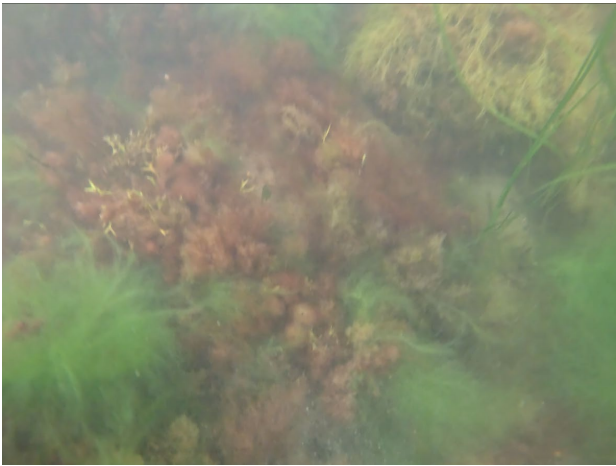
| LOCATION ID | PHOTOGRAPH | DESCRIPTION |
|---|---|---|
| 58 | | <i>Zostera marina</i> (eelgrass) rooted between large, seaweed-covered rocks. |

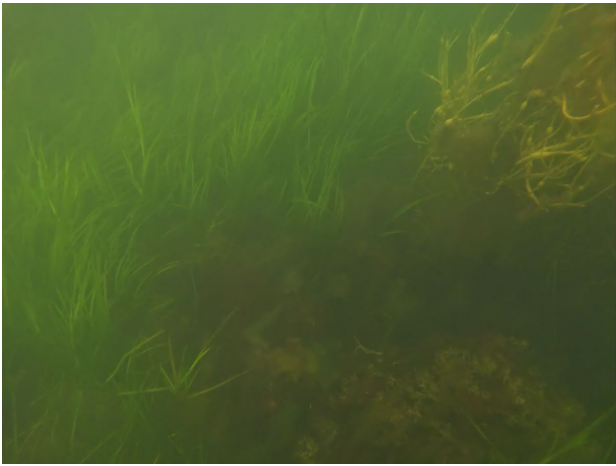
| LOCATION ID | PHOTOGRAPH | DESCRIPTION |
|---|---|---|
| 59 | | High-density mixed bed of <i>Zostera marina</i> (eelgrass) and <i>Ruppia maritima</i> (widgeon grass) growing around large, seaweed-covered rocks. |

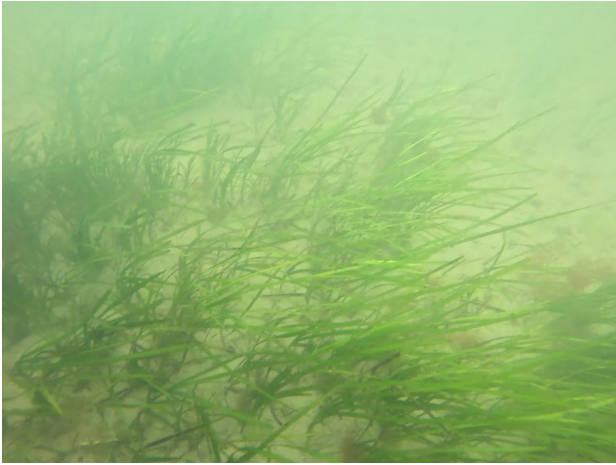
| LOCATION ID | PHOTOGRAPH | DESCRIPTION |
|---|---|---|
| 60 | | Edge of moderate-density mixed bed of <i>Zostera marina</i> (eelgrass) and <i>Ruppia maritima</i> (widgeon grass). |
